# Access Compliance Report

## Public Rights-of-Way

Intersection ID: N/A	Main Street: AKRAM_CT	Cross Street: MARY_JO_HELMS_DR	Location: SE
ADA ID: C1B35B454D14	Ramp Type: Combination1Diag	Initial Pass/Fail: Fail	Overall Compliance: No
		Severity Score: 0

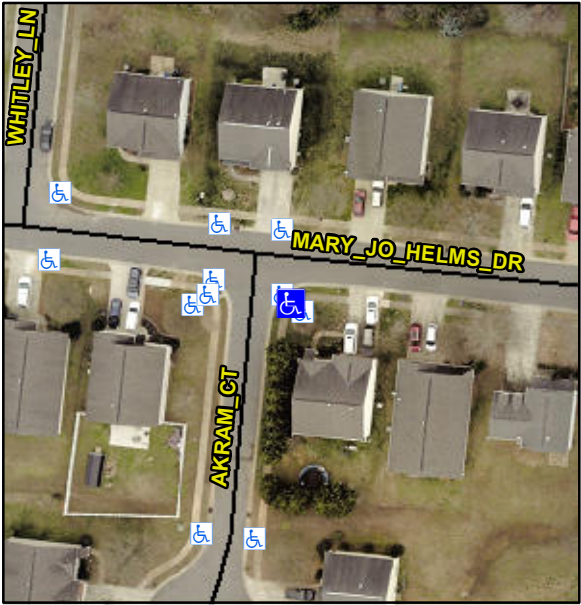
Possible Solutions:		<b>Compliance</b>	<b>Description</b>	<b>Data</b>
	<b>Remove &amp; Replace Curb Ramp With Two New Directional Ramps or Equivalent.</b>		<b>Compliance</b>	<b>Description</b>	<b>Data</b>
			N/A	Ramp Length LT (in)	38.5
			No	Ramp Width LT (in)	47.0
			Yes	Ramp Slope LT (%)	7.1
			No	Ramp XSlope LT (%)	2.3
			N/A	Ramp Length (in)	48.0
			No	Ramp Width (in)	41.0
			N/A	Flare Type LT	N/A
			N/A	Flare Slope LT (%)	N/A
			N/A	Flare Traversable LT?	N/A
			N/A	Landing Length (in)	N/A
			N/A	Landing Width (in)	N/A
			N/A	Landing Slope (%)	N/A
			N/A	Landing X Slope (%)	N/A
			N/A	Landing Curb? (Y/N)	N/A
			N/A	Shared Landing?	N/A
			N/A	Gutter Ponding?	N/A
			N/A	Gutter Lip Ht (in)	N/A
			N/A	Painted X Walk1?	No
				X Walk 1 Direction	To N
				X Walk 1 Width (in)	N/A
				X Walk 1 Slope (%)	1.4
				X Walk 1 X Slope (%)	2.1

N/A	Ramp inside XWalk1?	N/A
				Road Slope (%)	7.1
				Road X Slope (%)	3.0
			N/A	Ramp inside XWalk2?	N/A
				Clear Space?	N/A
				Clear Space to XWalk (in)	N/A
				Any Obstruction?	N/A
				Obstruction Type	N/A
					N/A
			N/A	Storm Grate/Utility Hazard?	N/A
				Storm Grate/Utility Type	N/A
					N/A
			Yes	Surface Condition? (G/P)	Good
				Curb Slope (%)	8.5

**Not Found, R304.5.1, R304.5.1, R304.5.3**

**Remove & Replace Curb Ramp With Two New Directional Ramps or Equivalent.**
