## **Access Compliance Report Public Rights-of-Way** (Curb Ramps)

Intersection ID: 29231 Main Street: KORNIV DR **Cross Street: COPPALA DR** Location: NW ADA ID: C1B7388D051C Ramp Type: PerpDiag Initial Pass/Fail: Pass **Overall Compliance: No Severity Score:** 27.5

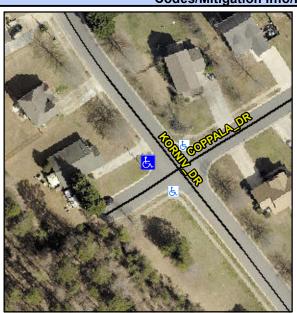
Field Measurements/Component Compliance					
Compliance Description		Data	Comp	liance Description	Data
N/A	Ramp Length (in)	97.0	Yes	Ramp Slope (%)	5.5
Yes	Ramp Width (in)	48.0	Yes	Ramp XSlope (%)	1.3
N/A	Flare Type LT	Sloped	N/A	Flare Type RT	N/A
N/A	Flare Slope LT (%)	3.5	Yes	Flare Slope RT (%)	6.1
N/A	Flare Traversable LT?	Yes	N/A	Flare Traversable RT?	Yes
No	Landing Length (in)	N/A	Yes	DWS Provided?	Yes
No	Landing Width (in)	N/A	Yes	DWS Contrast?	Yes
No	Landing Slope (%)	N/A	Yes	DWS Length (in)	24.0
No	Landing X Slope (%)	N/A	No	DWS Full Width?	No
N/A	Landing Curb? (Y/N)	No	No	DWS Offset (in)	6.5
N/A	Shared Landing?	No			
Yes	Gutter Ponding?	No	Yes	Gutter Slope (%)	0.8
No	Gutter Lip Ht (in)	1.0	Yes	Gutter X Slope (%)	1.5
N/A	Painted X Walk1?	No	N/A	Painted X Walk2?	No
	X Walk 1 Direction	To S		X Walk 2 Direction	To E
N/A	X Walk 1 Width (in)	N/A	N/A	X Walk 2 Width (in)	N/A
	X Walk 1 Slope (%)	2.7		X Walk 2 Slope (%)	5.3

X Walk 1 X Slope (%)	2.9		X Walk 2 X Slope (%)	1.5
N/A	Ramp inside XWalk1?	N/A	N/A	Ramp inside XWalk2?	N/A
	Road Slope (%)	0.6	N/A	Clear Space?	Yes
	Road X Slope (%)	5.1	N/A	Clear Space to XWalk (in)	N/A
Yes	Any Obstructions?	No	Yes	Storm Grate/Utility Hazard?	No
	Obstruction Type		l	Storm Grate/Utility Type	
		N/A			N/A
			Yes	Surface Condition? (G/P)	Good
THE THE

**COPPALA DR** Street 1 Name Stop Condition-Street 2 None Street 2 Name **KORNIV DR** Stop Condition-Street 1 None Possible Solutions: **Remove & Replace Curb Ramp With** Two New Directional Ramps or Equivalent. Surveyor Notes: N/A PROW/ADA: Not Found, R304.2.1, R304.2.2-Perp, R304.3.2-Para, R304.5.3, R305.1.4, R305.2, R302.7.2

Total Cost: 3200.00
