Access Compliance Report

Public Rights-of-Way

(Curb Ramps)

Intersection ID: 9330	Main Street: FRANKLIN_AV	Cross Street: RACHEL_ST	Location:	E
ADA ID: C1B8C896F500	Ramp Type: Para	Initial Pass/Fail: Fail	Overall Compliance: No	Severity Score: 25
Codes/Mitigation Info/Possible Solution		Field Measurements/Component Compliance

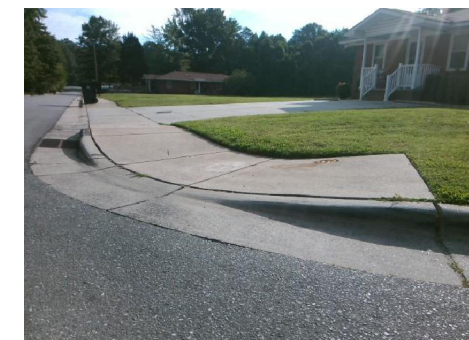
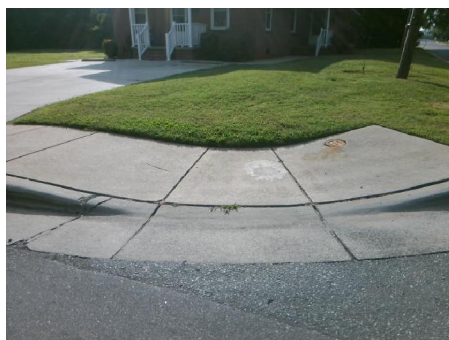
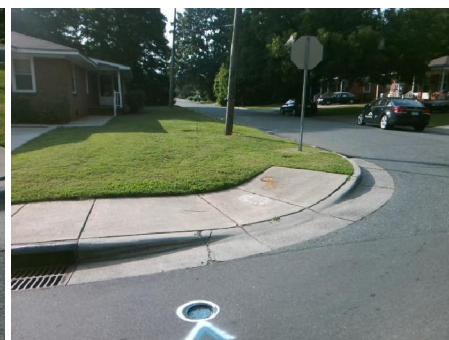
CURB GAP 1.5

Compliance	Description	Data	Compliance	Description	Data
N/A	Ramp Length LT (in)	58.0	N/A	Ramp Length RT (in)	54.5
Yes	Ramp Width LT (in)	60.0	Yes	Ramp Width RT (in)	59.0
Yes	Ramp Slope LT (%)	6.0	No	Ramp Slope RT (%)	12.8
Yes	Ramp XSlope LT (%)	1.7	Yes	Ramp XSlope RT (%)	2.0
N/A	Landing Length (in)	N/A	N/A	DWS Provided?	N/A
N/A	Landing Width (in)	N/A	N/A	DWS Contrast?	N/A
N/A	Landing Slope (%)	N/A	N/A	DWS Length (in)	N/A
N/A	Landing X Slope (%)	N/A	N/A	DWS Full Width?	N/A
N/A	Landing Curb? (Y/N)	N/A	N/A	DWS Offset (in)	N/A
N/A	Shared Landing?	N/A			
N/A	Gutter Ponding?	N/A	N/A	Gutter Slope (%)	N/A
N/A	Gutter Lip Ht (in)	N/A	N/A	Gutter X Slope (%)	N/A
N/A	Painted X Walk1?	No	N/A	Painted X Walk2?	N/A
	X Walk 1 Direction	To SW		X Walk 2 Direction	N/A
N/A	X Walk 1 Width (in)	N/A	N/A	X Walk 2 Width (in)	N/A
	X Walk 1 Slope (%)	4.7		X Walk 2 Slope (%)	N/A
	X Walk 1 X Slope (%)	1.1		X Walk 2 X Slope (%)	N/A
N/A	Ramp inside XWalk1?	N/A	N/A	Ramp inside XWalk2?	N/A

Road Slope (%)	N/A	N/A	Clear Space?	N/A
	Road X Slope (%)	N/A	N/A	Clear Space to XWalk (in)	N/A
N/A	Any Obstructions?	N/A	N/A	Storm Grate/Utility Hazard?	N/A
	Obstruction Type			Storm Grate/Utility Type	
		N/A			N/A
			Yes	Surface Condition? (G/P)	Good
			N/A	Curb Slope (%)	16.7

Possible Solutions:

Remove & Replace Entire Ramp.
