Access Compliance Report

Public Rights-of-Way

(Curb Ramps)

Intersection ID: N/A	Main Street: COMMUNITY_HOUSE_RD	Cross Street: N/A	Location: NW
ADA ID: C1CAD01B9B5D	Ramp Type: Perp	Initial Pass/Fail: Fail	Overall Compliance: No
Codes/Mitigation Info/Possible Solution		Field Measurements/Component Compliance	
Severity Score: 12.5

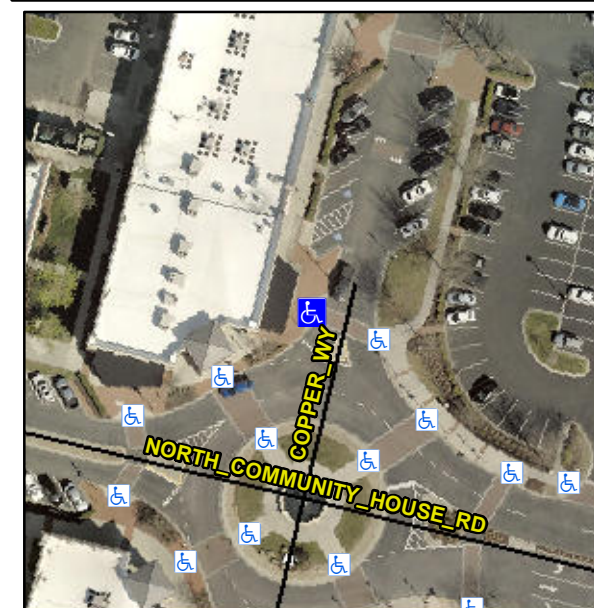
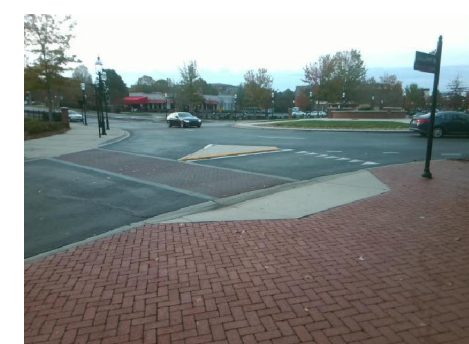
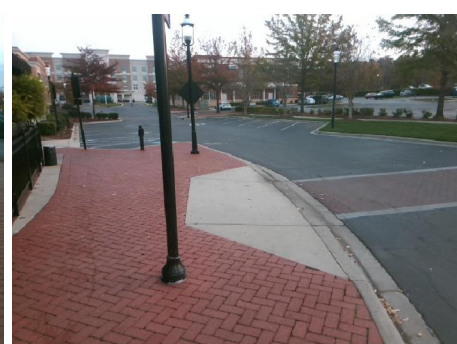
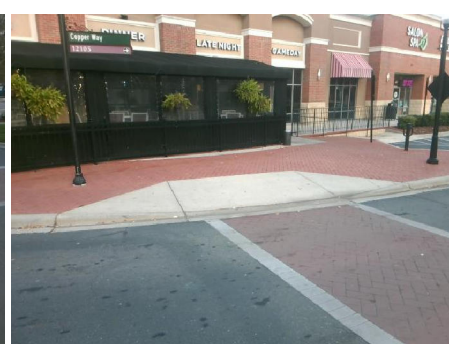
R304.2.2

Compliance	Description	Data	Compliance	Description	Data
N/A	Ramp Length (in)	73.5	No	Ramp Slope (%)	9.5
Yes	Ramp Width (in)	118.0	Yes	Ramp XSlope (%)	0.9
N/A	Flare Type LT	N/A	N/A	Flare Type RT	N/A
N/A	Flare Slope LT (%)	N/A	N/A	Flare Slope RT (%)	N/A
N/A	Flare Traversable LT?	N/A	N/A	Flare Traversable RT?	N/A
N/A	Landing Length (in)	N/A	N/A	DWS Provided?	N/A
N/A	Landing Width (in)	N/A	N/A	DWS Contrast?	N/A
N/A	Landing Slope (%)	N/A	N/A	DWS Length (in)	N/A
N/A	Landing X Slope (%)	N/A	N/A	DWS Full Width?	N/A
N/A	Landing Curb? (Y/N)	N/A	N/A	DWS Offset (in)	N/A
N/A	Shared Landing?	N/A			
N/A	Gutter Ponding?	N/A	N/A	Gutter Slope (%)	N/A
N/A	Gutter Lip Ht (in)	N/A	N/A	Gutter X Slope (%)	N/A
N/A	Painted X Walk1?	Yes	N/A	Painted X Walk2?	N/A
	X Walk 1 Direction	To SE		X Walk 2 Direction	N/A
N/A	X Walk 1 Width (in)	94.0	N/A	X Walk 2 Width (in)	N/A
	X Walk 1 Slope (%)	0.1		X Walk 2 Slope (%)	N/A
	X Walk 1 X Slope (%)	2.3		X Walk 2 X Slope (%)	N/A

N/A	Ramp inside XWalk1?	Yes	N/A	Ramp inside XWalk2?	N/A
	Road Slope (%)	N/A	N/A	Clear Space?	N/A
	Road X Slope (%)	N/A	N/A	Clear Space to XWalk (in)	N/A
N/A	Any Obstructions?	N/A	N/A	Storm Grate/Utility Hazard?	N/A
	Obstruction Type			Storm Grate/Utility Type	
		N/A			N/A
		Yes		Surface Condition? (G/P)	Good

Remove & Replace Entire Ramp.
