Access Compliance Report

Public Rights-of-Way

(Curb Ramps)

Intersection ID: 10025324	Main Street: E_5TH_ST	Cross Street: N/A	Location: NE
ADA ID: C1CC72858265	Ramp Type: Perp	Initial Pass/Fail: Fail	Overall Compliance: No
Severity Score: 13.75			
Codes/Mitigation Info/Possible Solution		Field Measurements/Component Compliance

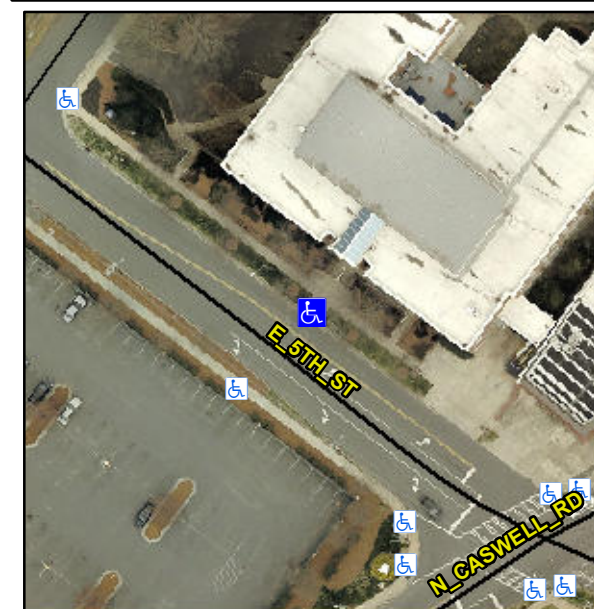
Compliance	Description	Data	Compliance	Description	Data
N/A	Ramp Length (in)	56.0	No	Ramp Slope (%)	10.1
Yes	Ramp Width (in)	68.0	Yes	Ramp XSlope (%)	2.2
N/A	Flare Type LT	N/A	N/A	Flare Type RT	N/A
N/A	Flare Slope LT (%)	N/A	N/A	Flare Slope RT (%)	N/A
N/A	Flare Traversable LT?	N/A	N/A	Flare Traversable RT?	N/A
N/A	Landing Length (in)	N/A	N/A	DWS Provided?	N/A
N/A	Landing Width (in)	N/A	N/A	DWS Contrast?	N/A
N/A	Landing Slope (%)	N/A	N/A	DWS Length (in)	N/A
N/A	Landing X Slope (%)	N/A	N/A	DWS Full Width?	N/A
N/A	Landing Curb? (Y/N)	N/A	N/A	DWS Offset (in)	N/A
N/A	Shared Landing?	N/A			
N/A	Gutter Ponding?	N/A	N/A	Gutter Slope (%)	N/A
N/A	Gutter Lip Ht (in)	N/A	N/A	Gutter X Slope (%)	N/A
N/A	Painted X Walk1?	No	N/A	Painted X Walk2?	N/A
	X Walk 1 Direction	To SW		X Walk 2 Direction	N/A
N/A	X Walk 1 Width (in)	N/A	N/A	X Walk 2 Width (in)	N/A
	X Walk 1 Slope (%)	2.9		X Walk 2 Slope (%)	N/A
	X Walk 1 X Slope (%)	2.4		X Walk 2 X Slope (%)	N/A

Possible Solutions:

Remove & Replace Entire Ramp.

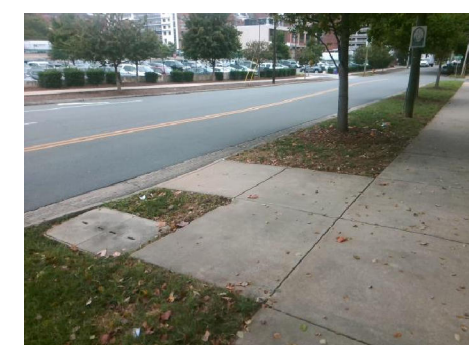
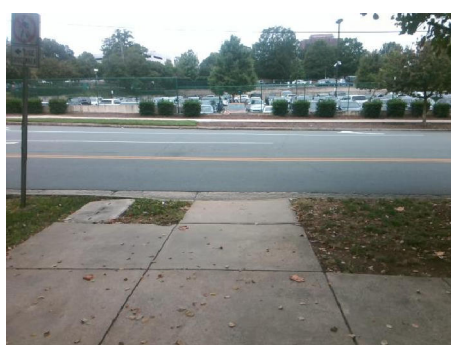
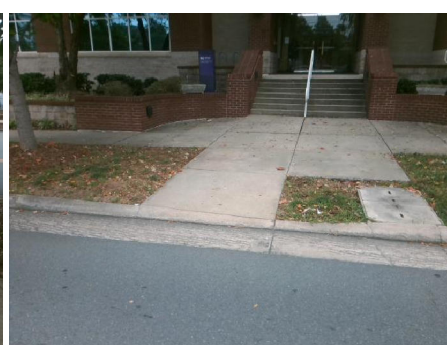
N/A	Ramp inside XWalk1?	N/A	N/A	Ramp inside XWalk2?	N/A
	Road Slope (%)	N/A	N/A	Clear Space?	N/A
	Road X Slope (%)	N/A	N/A	Clear Space to XWalk (in)	N/A
N/A	Any Obstructions?	N/A	N/A	Storm Grate/Utility Hazard?	N/A
	Obstruction Type			Storm Grate/Utility Type	
		N/A			N/A
			Yes	Surface Condition? (G/P)	Good
