Access Compliance Report

Public Rights-of-Way

(Curb Ramps)

Intersection ID: 29153	Main Street: BRIAR_ROSE_CT	Cross Street: HIGHLAND_PARK_DR	Location: W
ADA ID: C1D4EA3D31D2	Ramp Type: PerpDiag	Initial Pass/Fail: Fail	Overall Compliance: No
Severity Score: 8.75			
Codes/Mitigation Info/Possible Solution		Field Measurements/Component Compliance

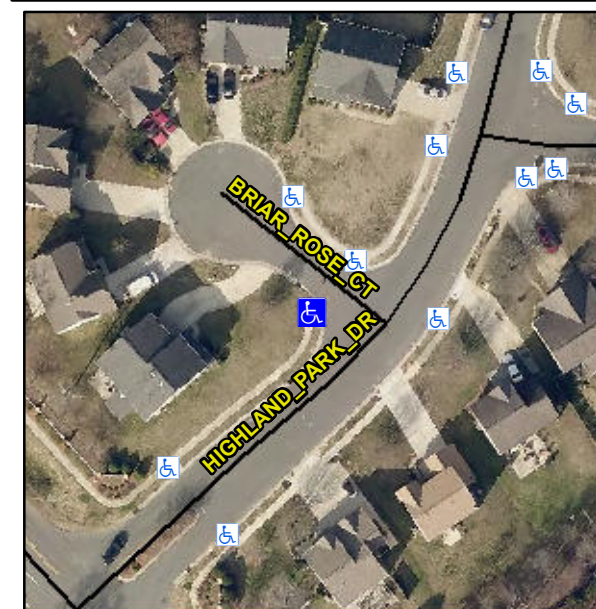
Compliance	Description	Data	Compliance	Description	Data
N/A	Ramp Length (in)	50.0	Yes	Ramp Slope (%)	6.8
No	Ramp Width (in)	47.0	Yes	Ramp XSlope (%)	0.5
N/A	Flare Type LT	N/A	N/A	Flare Type RT	N/A
N/A	Flare Slope LT (%)	N/A	N/A	Flare Slope RT (%)	N/A
N/A	Flare Traversable LT?	N/A	N/A	Flare Traversable RT?	N/A
N/A	Landing Length (in)	N/A	N/A	DWS Provided?	N/A
N/A	Landing Width (in)	N/A	N/A	DWS Contrast?	N/A
N/A	Landing Slope (%)	N/A	N/A	DWS Length (in)	N/A
N/A	Landing X Slope (%)	N/A	N/A	DWS Full Width?	N/A
N/A	Landing Curb? (Y/N)	N/A	N/A	DWS Offset (in)	N/A
N/A	Shared Landing?	N/A			
N/A	Gutter Ponding?	N/A	N/A	Gutter Slope (%)	N/A
N/A	Gutter Lip Ht (in)	N/A	N/A	Gutter X Slope (%)	N/A
N/A	Painted X Walk1?	No	N/A	Painted X Walk2?	No
	X Walk 1 Direction	To SE		X Walk 2 Direction	To NE
N/A	X Walk 1 Width (in)	N/A	N/A	X Walk 2 Width (in)	N/A
	X Walk 1 Slope (%)	1.5		X Walk 2 Slope (%)	1.8
	X Walk 1 X Slope (%)	0.2		X Walk 2 X Slope (%)	2.1

N/A	Ramp inside XWalk1?	N/A	N/A	Ramp inside XWalk2?	N/A
	Road Slope (%)	1.6	N/A	Clear Space?	N/A
	Road X Slope (%)	1.3	N/A	Clear Space to XWalk (in)	N/A
N/A	Any Obstructions?	N/A	N/A	Storm Grate/Utility Hazard?	N/A
	Obstruction Type			Storm Grate/Utility Type	
		N/A			N/A
			Yes	Surface Condition? (G/P)	Good

Possible Solutions:

Remove & Replace Curb Ramp With Two New Directional Ramps or Equivalent.
