Access Compliance Report

Public Rights-of-Way

(Curb Ramps)

Intersection ID: 10593	Main Street: BEATTIES_FORD_RD	Cross Street: ROZZELLES_FERRY_RD	Location: NW
ADA ID: C1D8EF12412D	Ramp Type: BlendTrans1	Initial Pass/Fail: Fail	Overall Compliance: No
Severity Score: 10			
Codes/Mitigation Info/Possible Solution		Field Measurements/Component Compliance

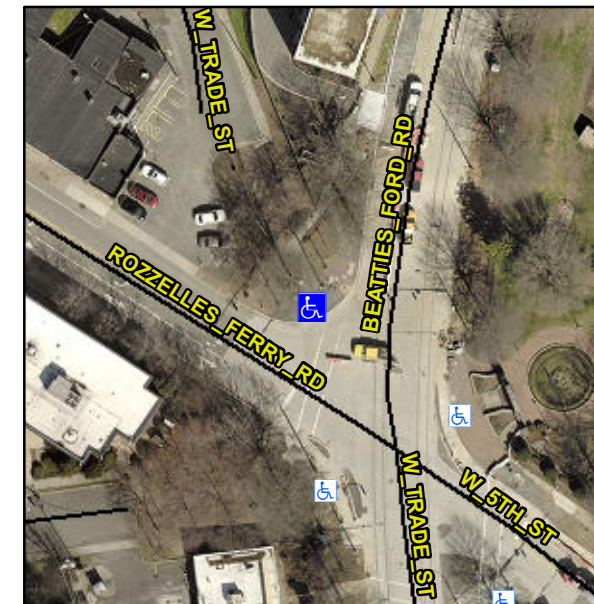
Not Found, R304.5.1, R304.5.3

Compliance	Description	Data	Compliance	Description	Data
N/A	Ramp Length (in)	67.0	Yes	BlendTrans Slope (%)	0.4
No	Ramp Width (in)	47.0	No	BlendTrans XSlope (%)	4.6
N/A	Flare Type LT	N/A	N/A	Flare Type RT	N/A
N/A	Flare Slope LT (%)	N/A	N/A	Flare Slope RT (%)	N/A
N/A	Flare Traversable LT?	N/A	N/A	Flare Traversable RT?	N/A
N/A	Landing Length (in)	N/A	N/A	DWS Provided?	N/A
N/A	Landing Width (in)	N/A	N/A	DWS Contrast?	N/A
N/A	Landing Slope (%)	N/A	N/A	DWS Length (in)	N/A
N/A	Landing X Slope (%)	N/A	N/A	DWS Full Width?	N/A
N/A	Landing Curb? (Y/N)	N/A	N/A	DWS Offset (in)	N/A
N/A	Shared Landing?	N/A			
N/A	Gutter Ponding?	N/A	N/A	Gutter Slope (%)	N/A
N/A	Gutter Lip Ht (in)	1.0	N/A	Gutter X Slope (%)	N/A
N/A	Painted X Walk1?	Yes	N/A	Painted X Walk2?	Yes
	X Walk 1 Direction	To S		X Walk 2 Direction	To SE
	X Walk 1 Width (in)	133.0		X Walk 2 Width (in)	105.0
	X Walk 1 Slope (%)	2.8		X Walk 2 Slope (%)	1.5
	X Walk 1 X Slope (%)	4.3		X Walk 2 X Slope (%)	2.6

N/A	Ramp inside XWalk1?	Yes	N/A	Ramp inside XWalk2?	Yes
	Road Slope (%)	4.6		Clear Space?	N/A
	Road X Slope (%)	0.5	N/A	Clear Space to XWalk (in)	N/A
N/A	Any Obstructions?	N/A	N/A	Storm Grate/Utility Hazard?	N/A
	Obstruction Type			Storm Grate/Utility Type	
		N/A			N/A
		Yes		Surface Condition? (G/P)	Good
		No		Curb Slope (%)	9.2

Remove & Replace Curb Ramp With Two New Directional Ramps or Equivalent.
