Access Compliance Report

Public Rights-of-Way

(Curb Ramps)

Intersection ID: 17042	Main Street: BUCKNELL_AV	Cross Street: QUEENS_RD_EAST	Location: W
ADA ID: C1DA6501B3EE	Ramp Type: Directional1	Initial Pass/Fail: Fail	Overall Compliance: No
Severity Score: 12.5			
Codes/Mitigation Info/Possible Solution		Field Measurements/Component Compliance

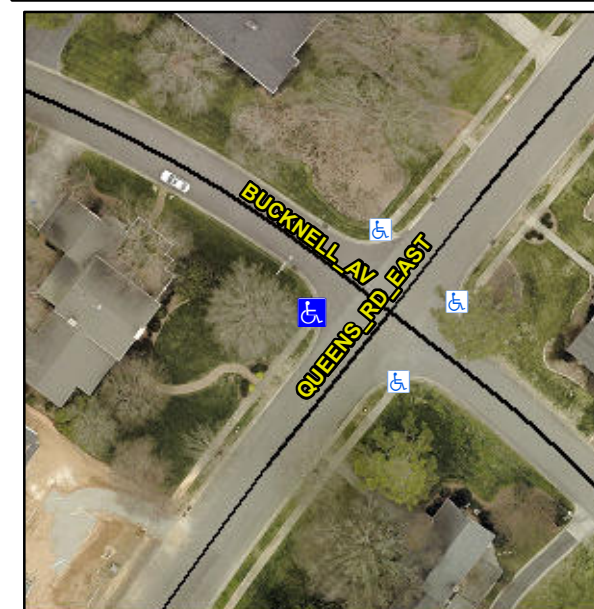
Compliance	Description	Data	Compliance	Description	Data
N/A	Ramp Length (in)	71.0	N/A	Grade Break?	N/A
Yes	Ramp Width (in)	48.0	N/A	Grade Break Slope (%)	0.0
Yes	Ramp Slope (%)	4.9	N/A	Grade Break XSlope (%)	0.0
No	Ramp XSlope (%)	5.8			
N/A	Flare Type LT	N/A	N/A	Flare Type RT	N/A
N/A	Flare Slope LT (%)	N/A	N/A	Flare Slope RT (%)	0.0
N/A	Flare Traversable LT?	N/A	N/A	Flare Traversable RT?	N/A
N/A	Landing Length (in)	0.0	N/A	DWS Provided?	N/A
N/A	Landing Width (in)	0.0	N/A	DWS Contrast?	N/A
N/A	Landing Slope (%)	0.0	N/A	DWS Length (in)	N/A
N/A	Landing X Slope (%)	0.0	N/A	DWS Full Width?	N/A
N/A	Landing Curb? (Y/N)	N/A	N/A	DWS Offset LT (in)	N/A
N/A	Shared Landing?	N/A	N/A	DWS Offset RT (in)	N/A
N/A	Gutter Ponding?	0.0	N/A	Gutter Slope (%)	N/A
N/A	Gutter Lip Ht (in)	0.0	N/A	Gutter X Slope (%)	N/A
N/A	Painted X Walk1?	No		Road Slope (%)	4.0
	X Walk 1 Direction	To NE		Road X Slope (%)	0.3
	X Walk 1 Width (in)	N/A		Clear Space?	N/A

X Walk 1 Slope (%)	4.0	N/A	Clear Space to XWalk (in)	N/A
	X Walk 1 X Slope (%)	0.3	N/A	Storm Grate/Utility Hazard?	N/A
N/A	Ramp inside XWalk1?	N/A		Storm Grate/Utility Type	
N/A	Any Obstructions?	N/A			N/A
	Obstruction Type		Yes	Surface Condition? (G/P)	Good
			N/A	Curb Slope (%)	5.6

Possible Solutions:

Remove & Replace Entire Ramp.
