# Access Compliance Report

## Public Rights-of-Way

### (Curb Ramps)

Intersection ID: 11839	Main Street: FLEETWOOD_DR	Cross Street: EVERGREEN_DR	Location: NE
ADA ID: C1E706E82E92	Ramp Type: Perp	Initial Pass/Fail: Fail	Overall Compliance: No
Severity Score: 25			
Codes/Mitigation Info/Possible Solution		Field Measurements/Component Compliance

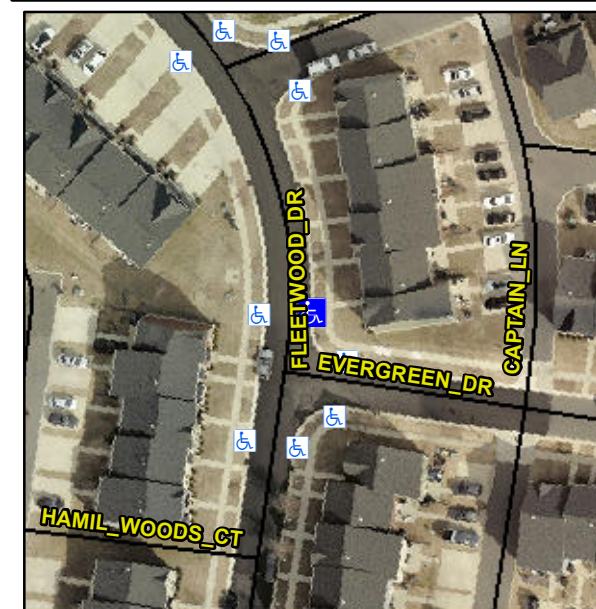
**Not Found, R304.2.2, R304.5.3**

Compliance	Description	Data	Compliance	Description	Data
N/A	Ramp Length (in)	72.5	No	Ramp Slope (%)	8.6
Yes	Ramp Width (in)	48.0	No	Ramp XSlope (%)	5.6
N/A	Flare Type LT	N/A	N/A	Flare Type RT	N/A
N/A	Flare Slope LT (%)	N/A	N/A	Flare Slope RT (%)	N/A
N/A	Flare Traversable LT?	N/A	N/A	Flare Traversable RT?	N/A
N/A	Landing Length (in)	N/A	N/A	DWS Provided?	N/A
N/A	Landing Width (in)	N/A	N/A	DWS Contrast?	N/A
N/A	Landing Slope (%)	N/A	N/A	DWS Length (in)	N/A
N/A	Landing X Slope (%)	N/A	N/A	DWS Full Width?	N/A
N/A	Landing Curb? (Y/N)	N/A	N/A	DWS Offset (in)	N/A
N/A	Shared Landing?	N/A			
N/A	Gutter Ponding?	N/A	N/A	Gutter Slope (%)	N/A
N/A	Gutter Lip Ht (in)	N/A	N/A	Gutter X Slope (%)	N/A
N/A	Painted X Walk1?	No	N/A	Painted X Walk2?	N/A
	X Walk 1 Direction	To W		X Walk 2 Direction	N/A
N/A	X Walk 1 Width (in)	N/A	N/A	X Walk 2 Width (in)	N/A
	X Walk 1 Slope (%)	4.5		X Walk 2 Slope (%)	N/A
	X Walk 1 X Slope (%)	5.4		X Walk 2 X Slope (%)	N/A

N/A	Ramp inside XWalk1?	N/A	N/A	Ramp inside XWalk2?	N/A
	Road Slope (%)	N/A	N/A	Clear Space?	N/A
	Road X Slope (%)	N/A	N/A	Clear Space to XWalk (in)	N/A
N/A	Any Obstructions?	N/A	N/A	Storm Grate/Utility Hazard?	N/A
	Obstruction Type			Storm Grate/Utility Type	
		N/A			N/A
			Yes	Surface Condition? (G/P)	Good

**Remove & Replace Entire Ramp.**
