Access Compliance Report

Public Rights-of-Way

(Curb Ramps)

Intersection ID: 7867	Main Street: BROOKTREE_DR	Cross Street: TODDVILLE_RD	Location: SE
ADA ID: C1EEC665B3B2	Ramp Type: Perp	Initial Pass/Fail: Fail	Overall Compliance: No
Severity Score: 21.25			
Codes/Mitigation Info/Possible Solution		Field Measurements/Component Compliance

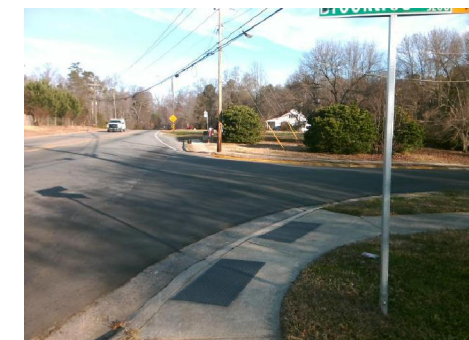
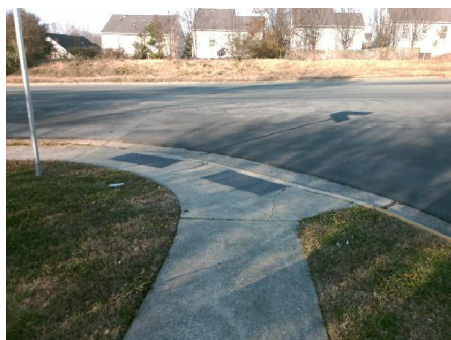
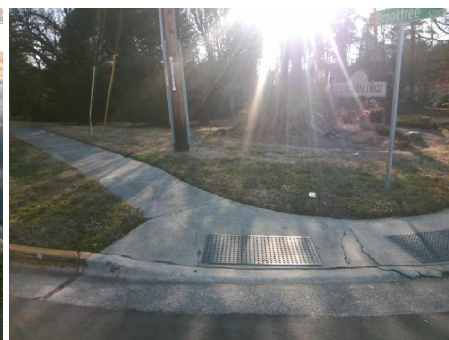
Not Found, R304.5.1, R304.5.3

Compliance	Description	Data	Compliance	Description	Data
N/A	Ramp Length (in)	54.0	Yes	Ramp Slope (%)	6.0
No	Ramp Width (in)	42.0	No	Ramp XSlope (%)	5.8
N/A	Flare Type LT	N/A	N/A	Flare Type RT	N/A
N/A	Flare Slope LT (%)	N/A	N/A	Flare Slope RT (%)	N/A
N/A	Flare Traversable LT?	N/A	N/A	Flare Traversable RT?	N/A
N/A	Landing Length (in)	N/A	N/A	DWS Provided?	N/A
N/A	Landing Width (in)	N/A	N/A	DWS Contrast?	N/A
N/A	Landing Slope (%)	N/A	N/A	DWS Length (in)	N/A
N/A	Landing X Slope (%)	N/A	N/A	DWS Full Width?	N/A
N/A	Landing Curb? (Y/N)	N/A	N/A	DWS Offset (in)	N/A
N/A	Shared Landing?	N/A			
N/A	Gutter Ponding?	N/A	N/A	Gutter Slope (%)	N/A
N/A	Gutter Lip Ht (in)	N/A	N/A	Gutter X Slope (%)	N/A
N/A	Painted X Walk1?	No	N/A	Painted X Walk2?	N/A
	X Walk 1 Direction	To N		X Walk 2 Direction	N/A
N/A	X Walk 1 Width (in)	N/A	N/A	X Walk 2 Width (in)	N/A
	X Walk 1 Slope (%)	7.1		X Walk 2 Slope (%)	N/A
	X Walk 1 X Slope (%)	3.1		X Walk 2 X Slope (%)	N/A

N/A	Ramp inside XWalk1?	N/A	N/A	Ramp inside XWalk2?	N/A
	Road Slope (%)	N/A	N/A	Clear Space?	N/A
	Road X Slope (%)	N/A	N/A	Clear Space to XWalk (in)	N/A
N/A	Any Obstructions?	N/A	N/A	Storm Grate/Utility Hazard?	N/A
	Obstruction Type			Storm Grate/Utility Type	
		N/A			N/A
		Yes		Surface Condition? (G/P)	Good

Remove & Replace Entire Ramp.
