Access Compliance Report

Public Rights-of-Way (Curb Ramps)

Intersection ID: 50313	Main Street: MASON_OAKS_CT	Cross Street: WINDEMERE_LN	Location: SW
ADA ID: C1F822185A91	Ramp Type: BlendTrans1	Initial Pass/Fail: Fail	Overall Compliance: No
		Severity Score: 8.75

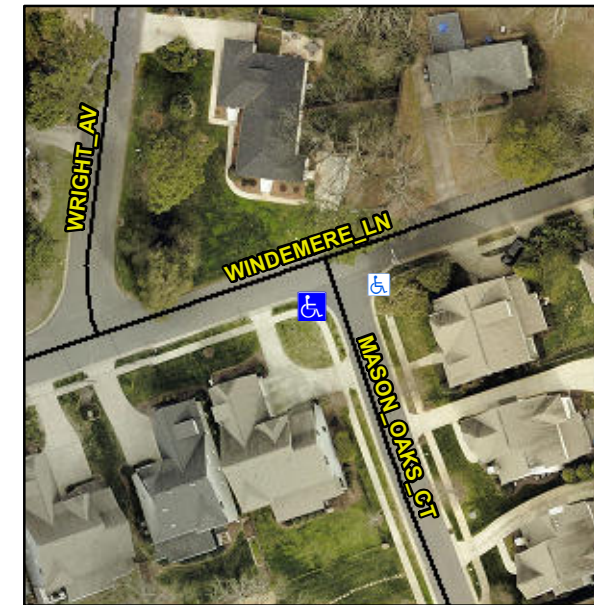
Not Found, R304.5.1

Compliance	Description	Data	Compliance	Description	Data
N/A	Ramp Length (in)	45.0	Yes	BlendTrans Slope (%)	3.7
No	Ramp Width (in)	46.5	Yes	BlendTrans XSlope (%)	1.0
N/A	Flare Type LT	N/A	N/A	Flare Type RT	N/A
N/A	Flare Slope LT (%)	N/A	N/A	Flare Slope RT (%)	N/A
N/A	Flare Traversable LT?	N/A	N/A	Flare Traversable RT?	N/A
N/A	Landing Length (in)	N/A	N/A	DWS Provided?	N/A
N/A	Landing Width (in)	N/A	N/A	DWS Contrast?	N/A
N/A	Landing Slope (%)	N/A	N/A	DWS Length (in)	N/A
N/A	Landing X Slope (%)	N/A	N/A	DWS Full Width?	N/A
N/A	Landing Curb? (Y/N)	N/A	N/A	DWS Offset (in)	N/A
N/A	Shared Landing?	N/A			
N/A	Gutter Ponding?	N/A	N/A	Gutter Slope (%)	N/A
N/A	Gutter Lip Ht (in)	N/A	N/A	Gutter X Slope (%)	N/A
N/A	Painted X Walk1?	No	N/A	Painted X Walk2?	N/A
	X Walk 1 Direction	To E		X Walk 2 Direction	N/A
	X Walk 1 Width (in)	N/A		X Walk 2 Width (in)	N/A
	X Walk 1 Slope (%)	4.4		X Walk 2 Slope (%)	N/A
	X Walk 1 X Slope (%)	3.8		X Walk 2 X Slope (%)	N/A

N/A	Ramp inside XWalk1?	N/A	N/A	Ramp inside XWalk2?	N/A
	Road Slope (%)	3.8		Clear Space?	N/A
	Road X Slope (%)	4.4	N/A	Clear Space to XWalk (in)	N/A
N/A	Any Obstructions?	N/A	N/A	Storm Grate/Utility Hazard?	N/A
	Obstruction Type			Storm Grate/Utility Type	
		N/A			N/A
			Yes	Surface Condition? (G/P)	Good
			No	Curb Slope (%)	14.2

Remove & Replace Curb Ramp With Two New Directional Ramps or Equivalent.
