Access Compliance Report

Public Rights-of-Way

(Curb Ramps)

Intersection ID: 20047	Main Street: SHARON_RD	Cross Street: MORRISON_BV	Location: S
ADA ID: C20A08F8EFAD	Ramp Type: PerpDiag	Initial Pass/Fail: Fail	Overall Compliance: No
Codes/Mitigation Info/Possible Solution		Field Measurements/Component Compliance	
Severity Score: 12.5

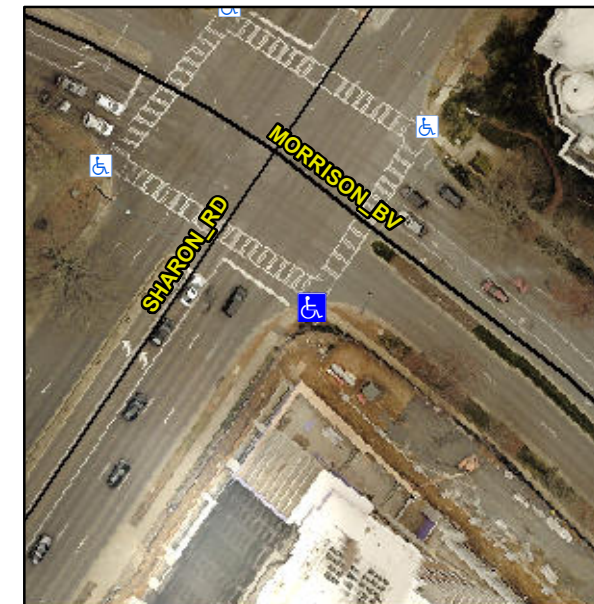
Compliance	Description	Data	Compliance	Description	Data
N/A	Ramp Length (in)	59.0	No	Ramp Slope (%)	9.0
Yes	Ramp Width (in)	58.5	Yes	Ramp XSlope (%)	0.2
N/A	Flare Type LT	N/A	N/A	Flare Type RT	N/A
N/A	Flare Slope LT (%)	N/A	N/A	Flare Slope RT (%)	N/A
N/A	Flare Traversable LT?	N/A	N/A	Flare Traversable RT?	N/A
N/A	Landing Length (in)	N/A	N/A	DWS Provided?	N/A
N/A	Landing Width (in)	N/A	N/A	DWS Contrast?	N/A
N/A	Landing Slope (%)	N/A	N/A	DWS Length (in)	N/A
N/A	Landing X Slope (%)	N/A	N/A	DWS Full Width?	N/A
N/A	Landing Curb? (Y/N)	N/A	N/A	DWS Offset (in)	N/A
N/A	Shared Landing?	N/A			
N/A	Gutter Ponding?	N/A	N/A	Gutter Slope (%)	N/A
N/A	Gutter Lip Ht (in)	N/A	N/A	Gutter X Slope (%)	N/A
N/A	Painted X Walk1?	Yes	N/A	Painted X Walk2?	Yes
	X Walk 1 Direction	To NE		X Walk 2 Direction	To NW
N/A	X Walk 1 Width (in)	106.0	N/A	X Walk 2 Width (in)	115.0
	X Walk 1 Slope (%)	0.0		X Walk 2 Slope (%)	4.0
	X Walk 1 X Slope (%)	3.8		X Walk 2 X Slope (%)	0.4

N/A	Ramp inside XWalk1?	Yes	N/A	Ramp inside XWalk2?	No
	Road Slope (%)	2.8	N/A	Clear Space?	N/A
	Road X Slope (%)	1.0	N/A	Clear Space to XWalk (in)	N/A
N/A	Any Obstructions?	N/A	N/A	Storm Grate/Utility Hazard?	N/A
	Obstruction Type			Storm Grate/Utility Type	
		N/A			N/A
		Yes		Surface Condition? (G/P)	Good

Possible Solutions:

Remove & Replace Curb Ramp With Two New Directional Ramps or Equivalent. Restripe Crosswalk.
