# Access Compliance Report

## Public Rights-of-Way

Intersection ID: 12787	Main Street: BANDY_DR	Cross Street: PENCE_RD	Location: SE
ADA ID: C20FD69FEAF5	Ramp Type: Para	Initial Pass/Fail: Fail	Overall Compliance: No
			Severity Score: 13.75

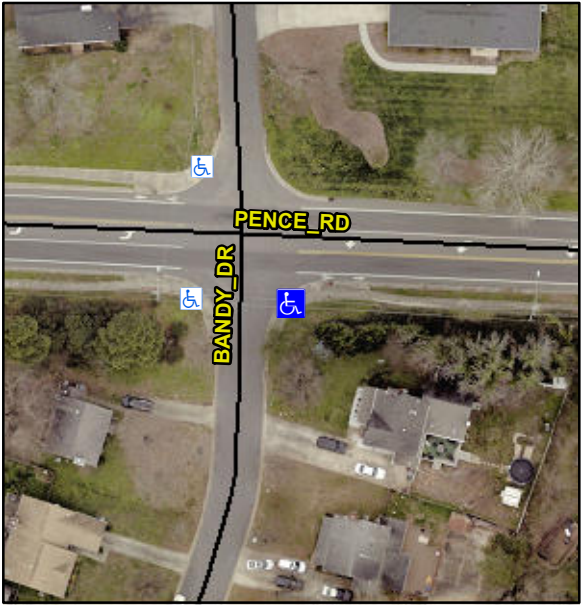
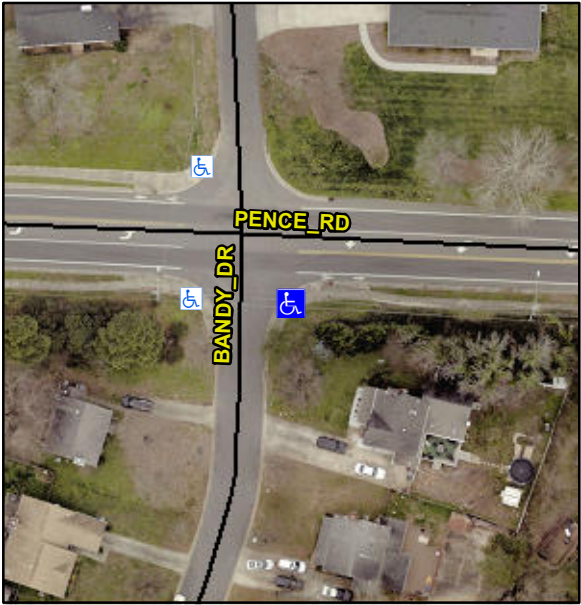
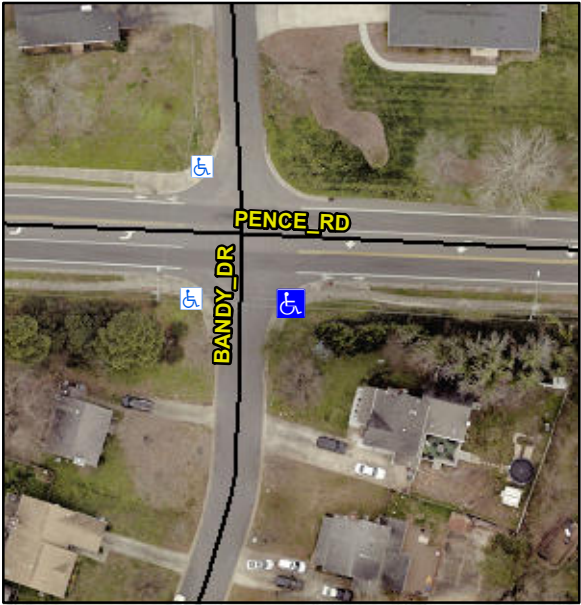
Possible Solutions:		<b>Compliance</b>	<b>Description</b>	<b>Data</b>
	<b>Remove &amp; Replace Entire Ramp.</b>		N/A	Ramp Length LT (in)	59.0
			Yes	Ramp Width LT (in)	76.0
			Yes	Ramp Slope LT (%)	2.9
			Yes	Ramp XSlope LT (%)	1.2
			N/A	Landing Length (in)	N/A
			N/A	Landing Width (in)	N/A
			N/A	Landing Slope (%)	N/A
			N/A	Landing X Slope (%)	N/A
			N/A	Landing Curb? (Y/N)	N/A

Surveyor Notes:		N/A	Shared Landing?	N/A
	<b>LT RP &lt; 5%</b>		N/A	Gutter Ponding?	N/A
			N/A	Gutter Lip Ht (in)	N/A
			N/A	Painted X Walk1?	No
			N/A	X Walk 1 Direction	To W
			N/A	X Walk 1 Width (in)	N/A
				X Walk 1 Slope (%)	4.0
				X Walk 1 X Slope (%)	1.3
			N/A	Ramp inside XWalk1?	N/A
			N/A	Road Slope (%)	N/A

PROW/ADA:		N/A	Road X Slope (%)	N/A
	<b>R304.3.2, R304.5.3</b>		N/A	Any Obstructions?	N/A
				Obstruction Type	
			N/A	Storm Grate/Utility Hazard?	N/A

Storm Grate/Utility Type	
			N/A		N/A
			Yes	Surface Condition? (G/P)	Good
			N/A	Curb Slope (%)	23.3
Total Cost:		\$ 1600.00
