# Access Compliance Report

## Public Rights-of-Way

### (Curb Ramps)

Intersection ID: 7091	Main Street: BROOKSHIRE_BV	Cross Street: HOVIS_RD	Location:	N
ADA ID: C21EA804E327	Ramp Type: Directional1	Initial Pass/Fail: Pass	Overall Compliance: No	Severity Score: 2.75
Codes/Mitigation Info/Possible Solution		Field Measurements/Component Compliance

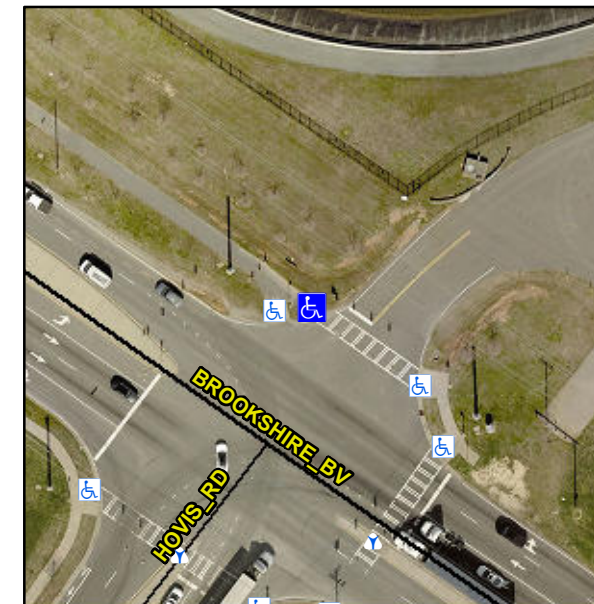
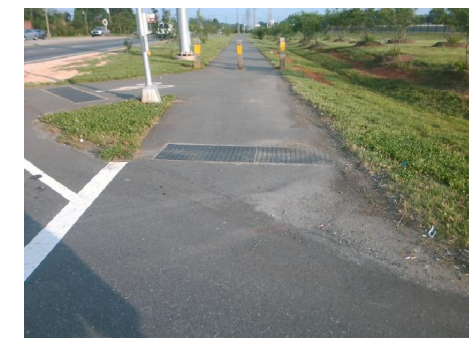
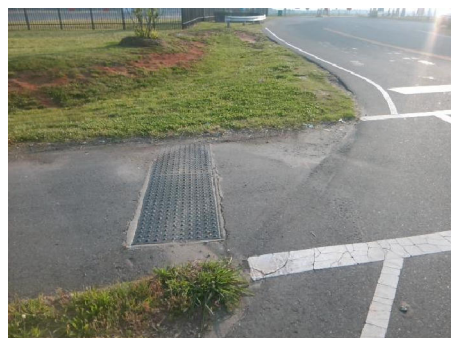
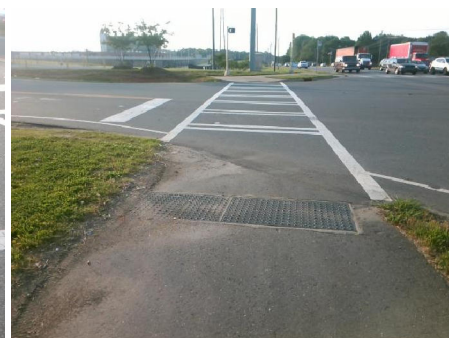
**NO CURB. DWS OS MEASURED TO ASP**

Compliance	Description	Data	Compliance	Description	Data
N/A	Ramp Length (in)	24.0	Yes	Grade Break?	Yes
Yes	Ramp Width (in)	110.0	Yes	Grade Break Slope (%)	0.9
Yes	Ramp Slope (%)	0.9	No	Grade Break XSlope (%)	2.8
No	Ramp XSlope (%)	2.1			
N/A	Flare Type LT	N/A	N/A	Flare Type RT	N/A
N/A	Flare Slope LT (%)	N/A	N/A	Flare Slope RT (%)	N/A
N/A	Flare Traversable LT?	N/A	N/A	Flare Traversable RT?	N/A
Yes	Landing Length (in)	48.0	Yes	DWS Provided?	Yes
Yes	Landing Width (in)	110.0	Yes	DWS Contrast?	Yes
Yes	Landing Slope (%)	0.0	Yes	DWS Length (in)	24.0
No	Landing X Slope (%)	2.2	No	DWS Full Width?	No
N/A	Landing Curb? (Y/N)	No	No	DWS Offset LT (in)	12.0
N/A	Shared Landing?	No	No	DWS Offset RT (in)	73.0
Yes	Gutter Ponding?	No	Yes	Gutter Slope (%)	1.2
Yes	Gutter Lip Ht (in)	0.0	Yes	Gutter X Slope (%)	0.7
N/A	Painted X Walk1?	Yes		Road Slope (%)	1.1
	X Walk 1 Direction	To SE		Road X Slope (%)	1.3
	X Walk 1 Width (in)	111.0		Clear Space?	Yes

X Walk 1 Slope (%)	1.1	N/A	Clear Space to XWalk (in)	N/A
	X Walk 1 X Slope (%)	1.3	Yes	Storm Grate/Utility Hazard?	No
Yes	Ramp inside XWalk1?	Yes		Storm Grate/Utility Type	
Yes	Any Obstructions?	No			N/A
	Obstruction Type		Yes	Surface Condition? (G/P)	Good
			N/A	Curb Slope (%)	2.0

**Remove & Replace Entire Ramp.**
