Access Compliance Report Public Rights-of-Way (Curb Ramps)

Intersection ID: 27419 Main Street: WILLIAMS_POND_LN Cross Street: WILLOWS_WISP_DR Location: W

ADA ID: C21F8746D402 Ramp Type: PerpDiag Initial Pass/Fail: Fail Overall Compliance: No Severity Score: 22.5

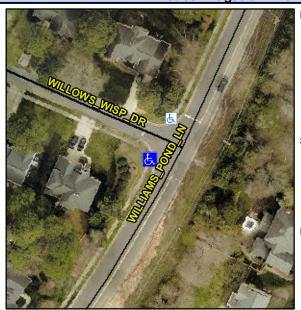
r leid Measurements/Component Comphance						
	Compliance Description		Data	Compliance Description		Data
	N/A	Ramp Length (in)	94.0	No	Ramp Slope (%)	9.5
	No	Ramp Width (in)	37.0	No	Ramp XSlope (%)	4.1
	N/A	Flare Type LT	N/A	N/A	Flare Type RT	N/A
	N/A	Flare Slope LT (%)	N/A	N/A	Flare Slope RT (%)	N/A
	N/A	Flare Traversable LT?	N/A	N/A	Flare Traversable RT?	N/A
	N/A	Landing Length (in)	N/A	N/A	DWS Provided?	N/A
	N/A	Landing Width (in)	N/A	N/A	DWS Contrast?	N/A
	N/A	Landing Slope (%)	N/A	N/A	DWS Length (in)	N/A
	N/A	Landing X Slope (%)	N/A	N/A	DWS Full Width?	N/A
	N/A	Landing Curb? (Y/N)	N/A	N/A	DWS Offset (in)	N/A
	N/A	Shared Landing?	N/A			
	N/A	Gutter Ponding?	N/A	N/A	Gutter Slope (%)	N/A
	N/A	Gutter Lip Ht (in)	N/A	N/A	Gutter X Slope (%)	N/A
	N/A	Painted X Walk1?	No	N/A	Painted X Walk2?	No
		X Walk 1 Direction	To SE		X Walk 2 Direction	To NE
	N/A	X Walk 1 Width (in)	N/A	N/A	X Walk 2 Width (in)	N/A
		X Walk 1 Slope (%)	9.1		X Walk 2 Slope (%)	0.7

X Walk 1 X Slope (%)	1.2		X Walk 2 X Slope (%)	4.2
	N/A	Ramp inside XWalk1?	N/A	N/A	Ramp inside XWalk2?	N/A
		Road Slope (%)	2.4	N/A	Clear Space?	N/A
		Road X Slope (%)	6.1	N/A	Clear Space to XWalk (in)	N/A
	N/A	Any Obstructions?	N/A	N/A	Storm Grate/Utility Hazard?	N/A
		Obstruction Type			Storm Grate/Utility Type

Remove & Replace Curb Ramp With Two New Directional Ramps or Equivalent.

R304.5.1, R304.2.2, R304.5.3
