# Access Compliance Report

## Public Rights-of-Way

### (Curb Ramps)

Intersection ID: N/A	Main Street: DIXIE_RIVER_RD	Cross Street: INVERNESS_BAY_RD	Location: SW
ADA ID: C220EBFB9749	Ramp Type: PerpDiag	Initial Pass/Fail: Fail	Overall Compliance: No
Severity Score: 12.5			
Codes/Mitigation Info/Possible Solution		Field Measurements/Component Compliance

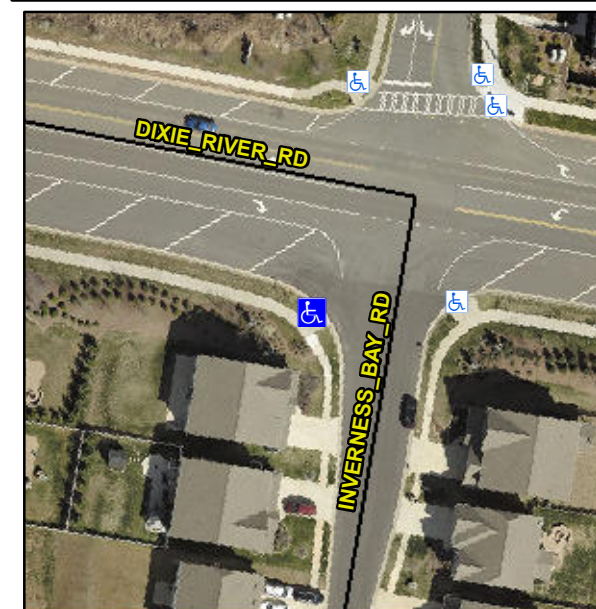
Compliance	Description	Data	Compliance	Description	Data
N/A	Ramp Length (in)	96.0	No	Ramp Slope (%)	9.9
Yes	Ramp Width (in)	48.0	Yes	Ramp XSlope (%)	1.5
N/A	Flare Type LT	N/A	N/A	Flare Type RT	N/A
N/A	Flare Slope LT (%)	N/A	N/A	Flare Slope RT (%)	N/A
N/A	Flare Traversable LT?	N/A	N/A	Flare Traversable RT?	N/A
N/A	Landing Length (in)	N/A	N/A	DWS Provided?	N/A
N/A	Landing Width (in)	N/A	N/A	DWS Contrast?	N/A
N/A	Landing Slope (%)	N/A	N/A	DWS Length (in)	N/A
N/A	Landing X Slope (%)	N/A	N/A	DWS Full Width?	N/A
N/A	Landing Curb? (Y/N)	N/A	N/A	DWS Offset (in)	N/A
N/A	Shared Landing?	N/A			
N/A	Gutter Ponding?	N/A	N/A	Gutter Slope (%)	N/A
N/A	Gutter Lip Ht (in)	1.0	N/A	Gutter X Slope (%)	N/A
N/A	Painted X Walk1?	No	N/A	Painted X Walk2?	No
	X Walk 1 Direction	To E		X Walk 2 Direction	To NE
N/A	X Walk 1 Width (in)	N/A	N/A	X Walk 2 Width (in)	N/A
	X Walk 1 Slope (%)	1.4		X Walk 2 Slope (%)	1.7
	X Walk 1 X Slope (%)	2.5		X Walk 2 X Slope (%)	0.1

N/A	Ramp inside XWalk1?	N/A	N/A	Ramp inside XWalk2?	N/A
	Road Slope (%)	0.7	N/A	Clear Space?	N/A
	Road X Slope (%)	1.9	N/A	Clear Space to XWalk (in)	N/A
N/A	Any Obstructions?	N/A	N/A	Storm Grate/Utility Hazard?	N/A
	Obstruction Type			Storm Grate/Utility Type	
		N/A			N/A
			Yes	Surface Condition? (G/P)	Good

**Remove & Replace Curb Ramp With Two New Directional Ramps or Equivalent.**

**R304.2.2**
