Access Compliance Report

Public Rights-of-Way

(Curb Ramps)

| Intersection ID: 2942 | Main Street: ASBURY_CHAPEL_RD | Cross Street: EASTFIELD_RD | Location: | E |

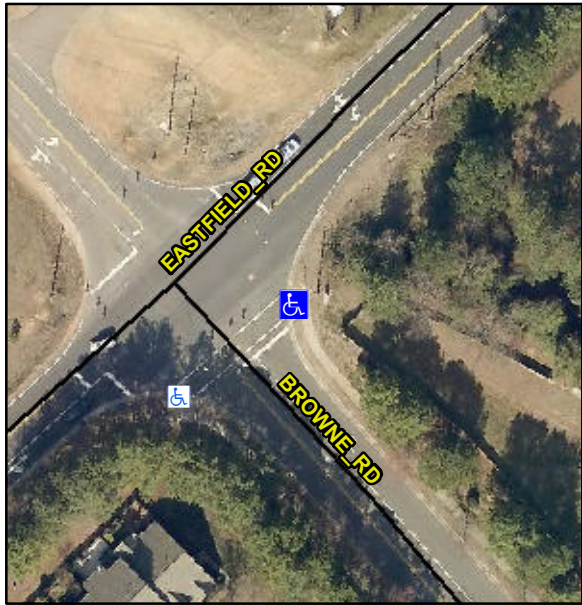
| ADA ID: C2239CDC7C31 | Ramp Type: Perp | Initial Pass/Fail: Fail | Overall Compliance: No | Severity Score: 12.5 |

| Codes/Mitigation Info/Possible Solution | | | Field Measurements/Component Compliance | | | | | |
|--|---|---|---|---|---|---|---|---|
| | Remove & Replace Entire Ramp. | | N/A | Ramp Length (in) | 60.0 | No | Ramp Slope (%) | 10.0 |
| Not Found, R304.2.2 | | | N/A | Gutter Lip Ht (in) | 1.0 | N/A | Gutter X Slope (%) | N/A |

| Codes/Mitigation Info/Possible Solution | | | Field Measurements/Component Compliance | | | | | |
|--|---|---|---|---|---|---|---|---|
| | Possible Solutions: | | Compliance | Description | Data | Compliance | Description | Data |
