## **Access Compliance Report Public Rights-of-Way** (Curb Ramps)

Intersection ID: 10031811 Main Street: MILLENNIUM\_AV Cross Street: SAGE\_PARK\_DR Location: **Overall Compliance: No ADA ID: C22748AA96DC** Ramp Type: Directional1 Initial Pass/Fail: Fail Severity Score: 13.75

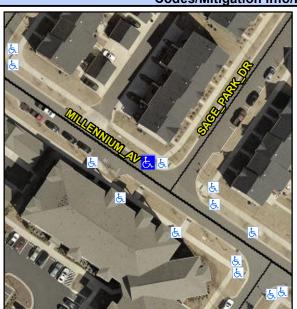
Field Measurements/Component Compliance							
Compl	iance Description	Data	Comp	liance Description	Data		
N/A	Ramp Length (in)	53.0	N/A	Grade Break?	N/A		
Yes	Ramp Width (in)	69.0	N/A	Grade Break Slope (%)	0.0		
No	Ramp Slope (%)	8.6	N/A	Grade Break XSlope (%)	0.0		
No	Ramp XSlope (%)	3.1					
N/A	Flare Type LT	N/A	N/A	Flare Type RT	N/A		
N/A	Flare Slope LT (%)	N/A	N/A	Flare Slope RT (%)	0.0		
N/A	Flare Traversable LT?	N/A	N/A	Flare Traversable RT?	N/A		
N/A	Landing Length (in)	0.0	N/A	DWS Provided?	N/A		
N/A	Landing Width (in)	0.0	N/A	DWS Contrast?	N/A		
N/A	Landing Slope (%)	0.0	N/A	DWS Length (in)	N/A		
N/A	Landing X Slope (%)	0.0	N/A	DWS Full Width?	N/A		
N/A	Landing Curb? (Y/N)	N/A	N/A	DWS Offset LT (in)	N/A		
N/A	Shared Landing?	N/A	N/A	DWS Offset RT (in)	N/A		
N/A	Gutter Ponding?	0.0	N/A	Gutter Slope (%)	N/A		
N/A	Gutter Lip Ht (in)	0.0	N/A	Gutter X Slope (%)	N/A		
N/A	Painted X Walk1?	No		Road Slope (%)	3.6

X Walk 1 Direction	To SW		Road X Slope (%)	2.5		
	X Walk 1 Width (in)	N/A		Clear Space?	N/A		
	X Walk 1 Slope (%)	3.6	N/A	Clear Space to XWalk (in)	N/A		
	X Walk 1 X Slope (%)	2.5	N/A	Storm Grate/Utility Hazard?	N/A		
N/A	Ramp inside XWalk1?	N/A		Storm Grate/Utility Type			
N/A	Any Obstructions?	N/A			N/A		
	Obstruction Type		Yes	Surface Condition? (G/P)	Good		
		N/A	N/A	Curb Slope (%)	8.7

Possible Solutions: Remove & Replace Entire Ramp. Surveyor Notes: N/A PROW/ADA: R304.2.2, R304.5.3
