# Access Compliance Report

## Public Rights-of-Way

### (Curb Ramps)

| Intersection ID: 17285 | Main Street: WESTMINSTER_PL | Cross Street: SHARON_RD | Location: W |

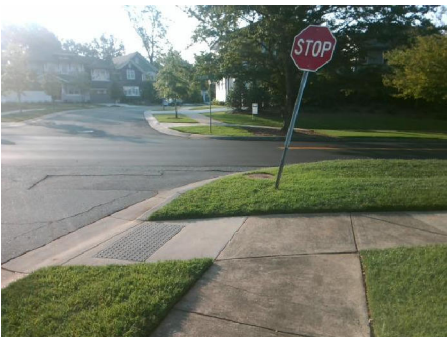
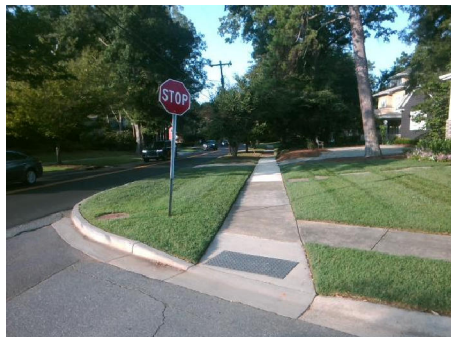
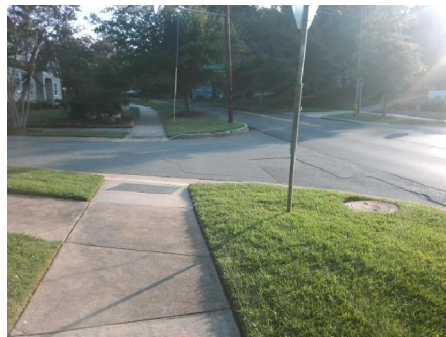
| ADA ID: C227F09D1742 | Ramp Type: BlendTrans1 | Initial Pass/Fail: Fail | Overall Compliance: No |

**Not Found, R304.5.3**

| Compliance | Description | Data | Compliance | Description | Data |
|---|---|---|---|---|---|
| Yes | Ramp Width (in) | <b>48.0</b> | No | BlendTrans XSlope (%) | <b>4.3</b> |
| | | | No | Curb Slope (%) | <b>9.3</b> |

**Remove & Replace Curb Ramp With Two New Directional Ramps or Equivalent.**
