# Access Compliance Report

## Public Rights-of-Way

### (Curb Ramps)

Intersection ID: 23533	Main Street: QUAIL_FOREST_DR	Cross Street: QUAIL_HOLLOW_RD	Location: NE
ADA ID: C22B410D358A	Ramp Type: PerpDiag	Initial Pass/Fail: Fail	Overall Compliance: No
		Severity Score: 10

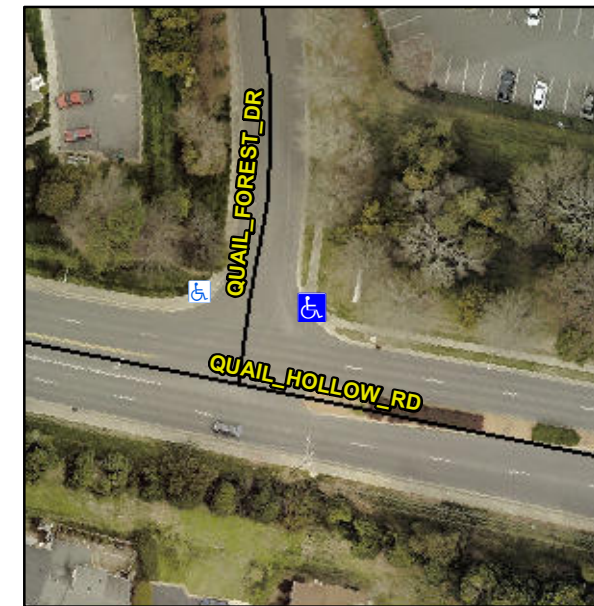
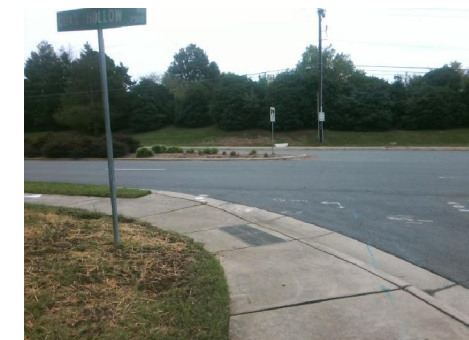
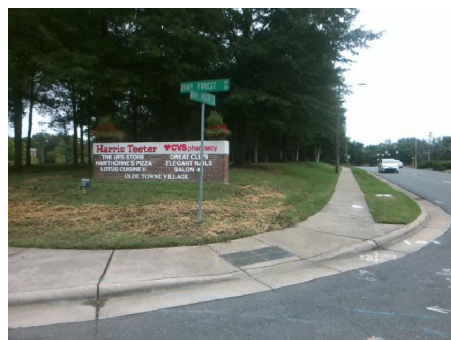
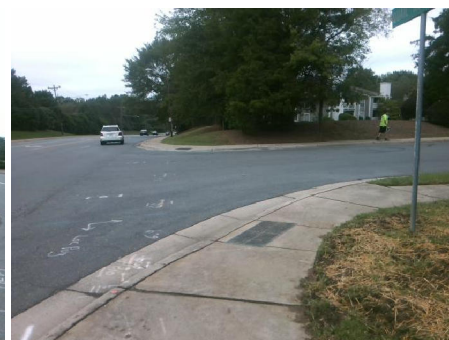
**Not Found, R304.5.1, R304.5.3**

Compliance	Description	Data	Compliance	Description	Data
N/A	Ramp Length (in)	58.0	Yes	Ramp Slope (%)	6.9
No	Ramp Width (in)	40.0	No	Ramp XSlope (%)	2.1
N/A	Flare Type LT	N/A	N/A	Flare Type RT	N/A
N/A	Flare Slope LT (%)	N/A	N/A	Flare Slope RT (%)	N/A
N/A	Flare Traversable LT?	N/A	N/A	Flare Traversable RT?	N/A
N/A	Landing Length (in)	N/A	N/A	DWS Provided?	N/A
N/A	Landing Width (in)	N/A	N/A	DWS Contrast?	N/A
N/A	Landing Slope (%)	N/A	N/A	DWS Length (in)	N/A
N/A	Landing X Slope (%)	N/A	N/A	DWS Full Width?	N/A
N/A	Landing Curb? (Y/N)	N/A	N/A	DWS Offset (in)	N/A
N/A	Shared Landing?	N/A			
N/A	Gutter Ponding?	N/A	N/A	Gutter Slope (%)	N/A
N/A	Gutter Lip Ht (in)	N/A	N/A	Gutter X Slope (%)	N/A
N/A	Painted X Walk1?	No	N/A	Painted X Walk2?	No
	X Walk 1 Direction	To NW		X Walk 2 Direction	To SW
N/A	X Walk 1 Width (in)	N/A	N/A	X Walk 2 Width (in)	N/A
	X Walk 1 Slope (%)	2.3		X Walk 2 Slope (%)	0.1
	X Walk 1 X Slope (%)	0.6		X Walk 2 X Slope (%)	1.0

N/A	Ramp inside XWalk1?	N/A	N/A	Ramp inside XWalk2?	N/A
	Road Slope (%)	2.1	N/A	Clear Space?	N/A
	Road X Slope (%)	4.1	N/A	Clear Space to XWalk (in)	N/A
N/A	Any Obstructions?	N/A	N/A	Storm Grate/Utility Hazard?	N/A
	Obstruction Type			Storm Grate/Utility Type	
		N/A			N/A
		Yes		Surface Condition? (G/P)	Good

**Remove & Replace Curb Ramp With Two New Directional Ramps or Equivalent.**

Total Cost: \$ 3200.00
