Access Compliance Report

Public Rights-of-Way

(Curb Ramps)

Intersection ID: 2464	Main Street: BENTGRASS_RUN_DR	Cross Street: BENTGRASS_RUN_DR	Location: W
ADA ID: C22E96517A34	Ramp Type: PerpDiag	Initial Pass/Fail: Fail	Overall Compliance: No
		Severity Score: 12.5

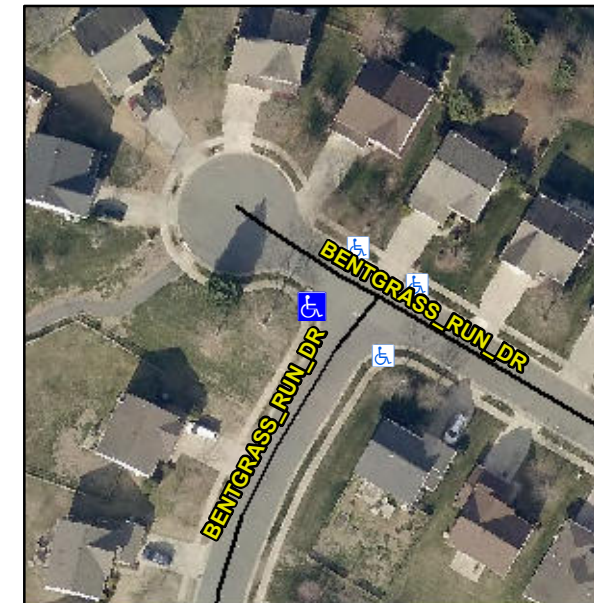
Compliance	Description	Data	Compliance	Description	Data
N/A	Ramp Length (in)	47.0	No	Ramp Slope (%)	8.5
Yes	Ramp Width (in)	96.0	Yes	Ramp XSlope (%)	2.0
N/A	Flare Type LT	N/A	N/A	Flare Type RT	N/A
N/A	Flare Slope LT (%)	N/A	N/A	Flare Slope RT (%)	N/A
N/A	Flare Traversable LT?	N/A	N/A	Flare Traversable RT?	N/A
N/A	Landing Length (in)	N/A	N/A	DWS Provided?	N/A
N/A	Landing Width (in)	N/A	N/A	DWS Contrast?	N/A
N/A	Landing Slope (%)	N/A	N/A	DWS Length (in)	N/A
N/A	Landing X Slope (%)	N/A	N/A	DWS Full Width?	N/A
N/A	Landing Curb? (Y/N)	N/A	N/A	DWS Offset (in)	N/A
N/A	Shared Landing?	N/A			
N/A	Gutter Ponding?	N/A	N/A	Gutter Slope (%)	N/A
N/A	Gutter Lip Ht (in)	N/A	N/A	Gutter X Slope (%)	N/A
N/A	Painted X Walk1?	No	N/A	Painted X Walk2?	No
	X Walk 1 Direction	To SE		X Walk 2 Direction	To NE
N/A	X Walk 1 Width (in)	N/A	N/A	X Walk 2 Width (in)	N/A
	X Walk 1 Slope (%)	1.1		X Walk 2 Slope (%)	0.4
	X Walk 1 X Slope (%)	0.9		X Walk 2 X Slope (%)	0.1

N/A	Ramp inside XWalk1?	N/A	N/A	Ramp inside XWalk2?	N/A
	Road Slope (%)	0.4	N/A	Clear Space?	N/A
	Road X Slope (%)	0.3	N/A	Clear Space to XWalk (in)	N/A
N/A	Any Obstructions?	N/A	N/A	Storm Grate/Utility Hazard?	N/A
	Obstruction Type			Storm Grate/Utility Type	
		N/A			N/A
			Yes	Surface Condition? (G/P)	Good

Possible Solutions:

Remove & Replace Curb Ramp With Two New Directional Ramps or Equivalent.

R304.2.2
