Access Compliance Report

Public Rights-of-Way

(Curb Ramps)

Intersection ID: 14094		Main Street: BERKELEY_AV		Cross Street: MYRTLE_AV		Location: SE			
ADA ID: C22FBA87E2F6		Ramp Type: PerpDiag		Initial Pass/Fail: Fail		Overall Compliance: No		Severity Score: 12.5	
Codes/Mitigation Info/Possible Solution					Field Measurements/Component Compliance

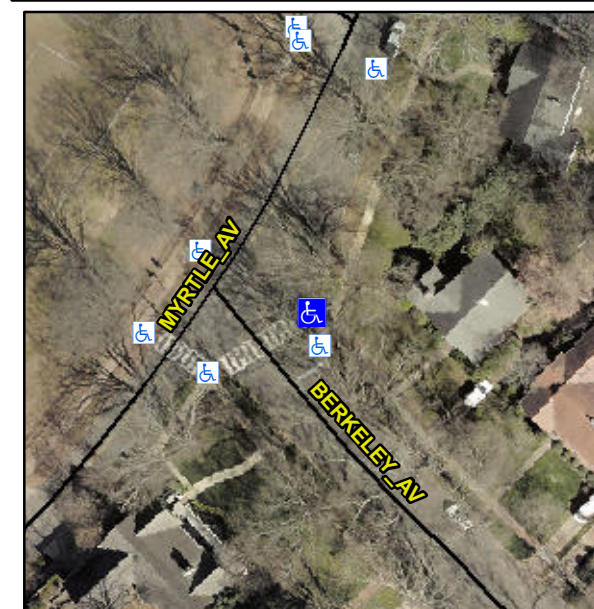
Not Found, R304.5.3

Compliance	Description	Data	Compliance	Description	Data
N/A	Ramp Length (in)	30.0	Yes	Ramp Slope (%)	7.1
Yes	Ramp Width (in)	60.0	No	Ramp XSlope (%)	5.1
N/A	Flare Type LT	N/A	N/A	Flare Type RT	N/A
N/A	Flare Slope LT (%)	N/A	N/A	Flare Slope RT (%)	N/A
N/A	Flare Traversable LT?	N/A	N/A	Flare Traversable RT?	N/A
N/A	Landing Length (in)	N/A	N/A	DWS Provided?	N/A
N/A	Landing Width (in)	N/A	N/A	DWS Contrast?	N/A
N/A	Landing Slope (%)	N/A	N/A	DWS Length (in)	N/A
N/A	Landing X Slope (%)	N/A	N/A	DWS Full Width?	N/A
N/A	Landing Curb? (Y/N)	N/A	N/A	DWS Offset (in)	N/A
N/A	Shared Landing?	N/A			
N/A	Gutter Ponding?	N/A	N/A	Gutter Slope (%)	N/A
N/A	Gutter Lip Ht (in)	N/A	N/A	Gutter X Slope (%)	N/A
N/A	Painted X Walk1?	No	N/A	Painted X Walk2?	Yes
	X Walk 1 Direction	To NW		X Walk 2 Direction	To SW
N/A	X Walk 1 Width (in)	N/A	N/A	X Walk 2 Width (in)	111.0
	X Walk 1 Slope (%)	2.5		X Walk 2 Slope (%)	5.1
	X Walk 1 X Slope (%)	3.8		X Walk 2 X Slope (%)	3.2

N/A	Ramp inside XWalk1?	N/A	N/A	Ramp inside XWalk2?	Yes
	Road Slope (%)	0.6	N/A	Clear Space?	N/A
	Road X Slope (%)	7.0	N/A	Clear Space to XWalk (in)	N/A
N/A	Any Obstructions?	N/A	N/A	Storm Grate/Utility Hazard?	N/A
	Obstruction Type			Storm Grate/Utility Type	
		N/A			N/A
		Yes		Surface Condition? (G/P)	Good

Remove & Replace Curb Ramp With Two New Directional Ramps or Equivalent.

Total Cost: \$ 3200.00
