Access Compliance Report

Public Rights-of-Way

(Curb Ramps)

Intersection ID: 10443	Main Street: JORDAN_PL	Cross Street: N_BREVARD_ST	Location: S
ADA ID: C232A9A67757	Ramp Type: BlendTrans1	Initial Pass/Fail: Fail	Overall Compliance: No
		Severity Score: 10

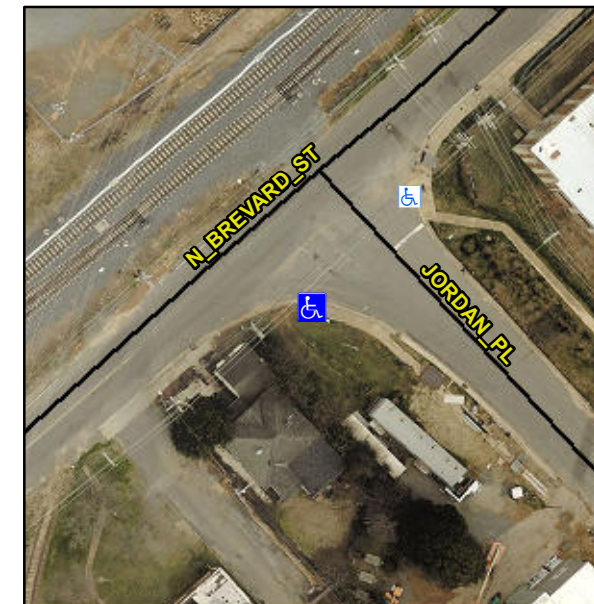
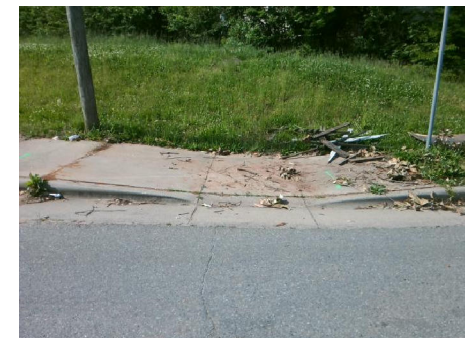
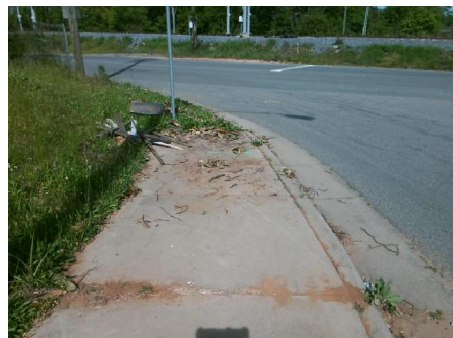
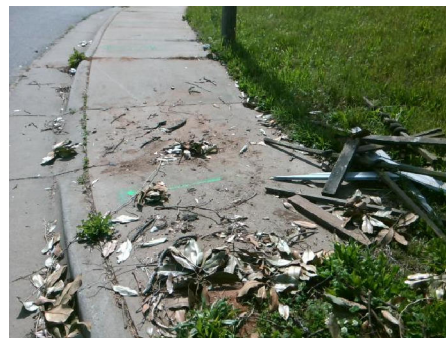
DWS NAIL EXPOSED

Not Found, R304.5.1, R304.5.3

Compliance	Description	Data	Compliance	Description	Data
N/A	Ramp Length (in)	54.5	Yes	BlendTrans Slope (%)	4.1
No	Ramp Width (in)	43.0	No	BlendTrans XSlope (%)	5.0
N/A	Flare Type LT	N/A	N/A	Flare Type RT	N/A
N/A	Flare Slope LT (%)	N/A	N/A	Flare Slope RT (%)	N/A
N/A	Flare Traversable LT?	N/A	N/A	Flare Traversable RT?	N/A
N/A	Landing Length (in)	N/A	N/A	DWS Provided?	N/A
N/A	Landing Width (in)	N/A	N/A	DWS Contrast?	N/A
N/A	Landing Slope (%)	N/A	N/A	DWS Length (in)	N/A
N/A	Landing X Slope (%)	N/A	N/A	DWS Full Width?	N/A
N/A	Landing Curb? (Y/N)	N/A	N/A	DWS Offset (in)	N/A
N/A	Shared Landing?	N/A			
N/A	Gutter Ponding?	N/A	N/A	Gutter Slope (%)	N/A
N/A	Gutter Lip Ht (in)	N/A	N/A	Gutter X Slope (%)	N/A
N/A	Painted X Walk1?	No	N/A	Painted X Walk2?	N/A
	X Walk 1 Direction	To NE		X Walk 2 Direction	N/A
	X Walk 1 Width (in)	N/A		X Walk 2 Width (in)	N/A
	X Walk 1 Slope (%)	2.7		X Walk 2 Slope (%)	N/A
	X Walk 1 X Slope (%)	1.3		X Walk 2 X Slope (%)	N/A

N/A	Ramp inside XWalk1?	N/A	N/A	Ramp inside XWalk2?	N/A
	Road Slope (%)	1.3		Clear Space?	N/A
	Road X Slope (%)	2.7	N/A	Clear Space to XWalk (in)	N/A
N/A	Any Obstructions?	N/A	N/A	Storm Grate/Utility Hazard?	N/A
	Obstruction Type			Storm Grate/Utility Type	
		N/A			N/A
			Yes	Surface Condition? (G/P)	Good
			No	Curb Slope (%)	16.5

Remove & Replace Curb Ramp With Two New Directional Ramps or Equivalent.
