Access Compliance Report

Public Rights-of-Way

(Curb Ramps)

Intersection ID: 10021488	Main Street: BOSTON_AV	Cross Street: N/A	Location: SW
ADA ID: C234B839FC9F	Ramp Type: PerpDiag	Initial Pass/Fail: Fail	Overall Compliance: No
		Severity Score: 60

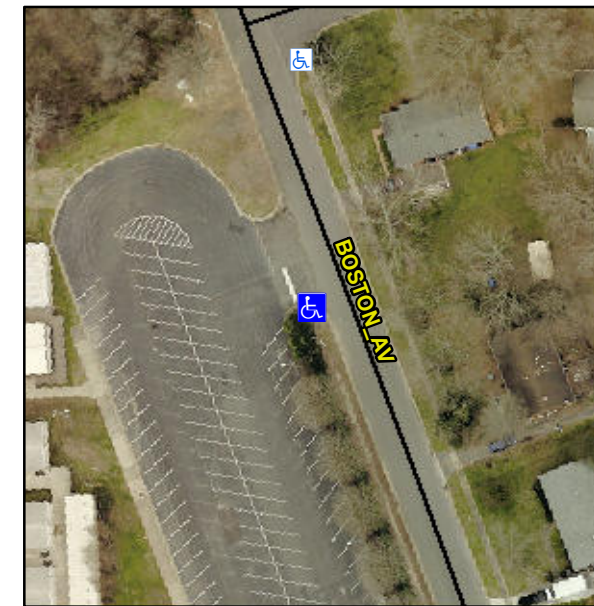
Not Found, R304.5.1, R304.5.3

Compliance	Description	Data	Compliance	Description	Data
N/A	Ramp Length (in)	90.0	Yes	Ramp Slope (%)	6.4
No	Ramp Width (in)	25.0	No	Ramp XSlope (%)	7.8
N/A	Flare Type LT	N/A	N/A	Flare Type RT	N/A
N/A	Flare Slope LT (%)	N/A	N/A	Flare Slope RT (%)	N/A
N/A	Flare Traversable LT?	N/A	N/A	Flare Traversable RT?	N/A
N/A	Landing Length (in)	N/A	N/A	DWS Provided?	N/A
N/A	Landing Width (in)	N/A	N/A	DWS Contrast?	N/A
N/A	Landing Slope (%)	N/A	N/A	DWS Length (in)	N/A
N/A	Landing X Slope (%)	N/A	N/A	DWS Full Width?	N/A
N/A	Landing Curb? (Y/N)	N/A	N/A	DWS Offset (in)	N/A
N/A	Shared Landing?	N/A			
N/A	Gutter Ponding?	N/A	N/A	Gutter Slope (%)	N/A
N/A	Gutter Lip Ht (in)	N/A	N/A	Gutter X Slope (%)	N/A
N/A	Painted X Walk1?	No	N/A	Painted X Walk2?	No
	X Walk 1 Direction	To E		X Walk 2 Direction	To N
N/A	X Walk 1 Width (in)	N/A	N/A	X Walk 2 Width (in)	N/A
	X Walk 1 Slope (%)	1.4		X Walk 2 Slope (%)	2.6
	X Walk 1 X Slope (%)	1.6		X Walk 2 X Slope (%)	14.2

N/A	Ramp inside XWalk1?	N/A	N/A	Ramp inside XWalk2?	N/A
	Road Slope (%)	6.5	N/A	Clear Space?	N/A
	Road X Slope (%)	12.9	N/A	Clear Space to XWalk (in)	N/A
N/A	Any Obstructions?	N/A	N/A	Storm Grate/Utility Hazard?	N/A
	Obstruction Type			Storm Grate/Utility Type	
		N/A			N/A
			Yes	Surface Condition? (G/P)	Good

Remove & Replace Curb Ramp With Two New Directional Ramps or Equivalent.
