Access Compliance Report

Public Rights-of-Way

(Curb Ramps)

Intersection ID: 8483	Main Street: KENNESAW_DR	Cross Street: LASALLE_ST	Location: SE
ADA ID: C24480FBDA26	Ramp Type: PerpDiag	Initial Pass/Fail: Fail	Overall Compliance: No
			Severity Score: 21.25

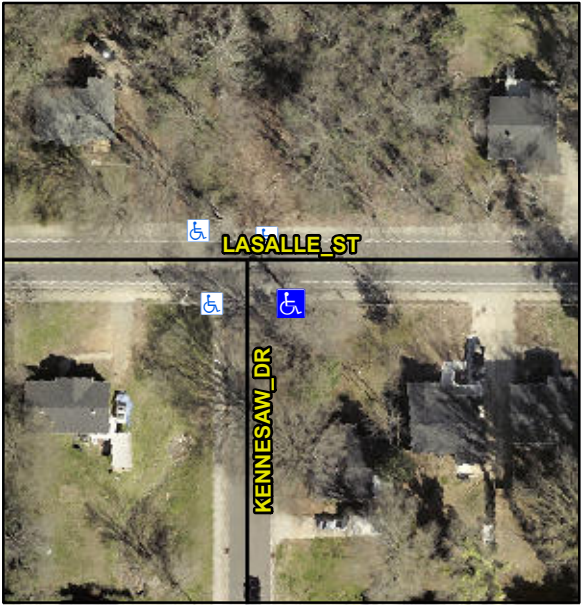
Possible Solutions:	Remove & Replace Curb Ramp With Two New Directional Ramps or Equivalent.					
	Surveyor Notes:	N/A					
	PROW/ADA:	Not Found, R304.5.1, R304.5.3					
			Compliance	Description	Data	Compliance	Description
			N/A	Ramp Length (in)	59.5	Yes	Ramp Slope (%)
			No	Ramp Width (in)	36.0	No	Ramp XSlope (%)
			N/A	Flare Type LT	N/A	N/A	Flare Type RT
			N/A	Flare Slope LT (%)	N/A	N/A	Flare Slope RT (%)
			N/A	Flare Traversable LT?	N/A	N/A	Flare Traversable RT?
			N/A	Landing Length (in)	N/A	N/A	DWS Provided?
			N/A	Landing Width (in)	N/A	N/A	DWS Contrast?
			N/A	Landing Slope (%)	N/A	N/A	DWS Length (in)
			N/A	Landing X Slope (%)	N/A	N/A	DWS Full Width?
			N/A	Landing Curb? (Y/N)	N/A	N/A	DWS Offset (in)
			N/A	Shared Landing?	N/A		
			N/A	Gutter Ponding?	N/A	N/A	Gutter Slope (%)
			N/A	Gutter Lip Ht (in)	0.5	N/A	Gutter X Slope (%)

N/A	Painted X Walk1?	No	N/A	Painted X Walk2?
				X Walk 1 Direction	To N		X Walk 2 Direction
			N/A	X Walk 1 Width (in)	N/A	N/A	X Walk 2 Width (in)
				X Walk 1 Slope (%)	4.6		X Walk 2 Slope (%)
				X Walk 1 X Slope (%)	5.4		X Walk 2 X Slope (%)
			N/A	Ramp inside XWalk1?	N/A	N/A	Ramp inside XWalk2?
				Road Slope (%)	2.2	N/A	Clear Space?
				Road X Slope (%)	7.9	N/A	Clear Space to XWalk (in)
			N/A	Any Obstructions?	N/A	N/A	Storm Grate/Utility Hazard?
				Obstruction Type			Storm Grate/Utility Type
					N/A		N/A
						Yes	Surface Condition? (G/P)
							Good
