# Access Compliance Report

## Public Rights-of-Way

### (Curb Ramps)

Intersection ID: 52476	Main Street: WHITEHALL_EXECUTIVE_CENTER_DR	Cross Street: N/A	Location: SE
ADA ID: C24E557A24CA	Ramp Type: Perp	Initial Pass/Fail: Fail	Overall Compliance: No
Severity Score: 1.25			
Codes/Mitigation Info/Possible Solution		Field Measurements/Component Compliance

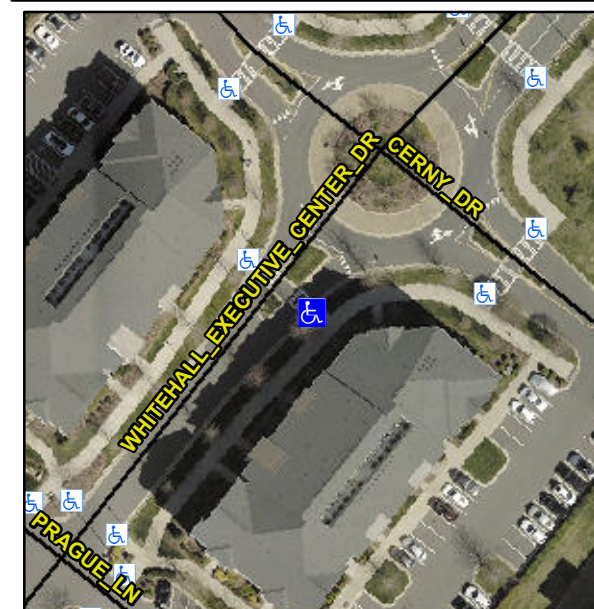
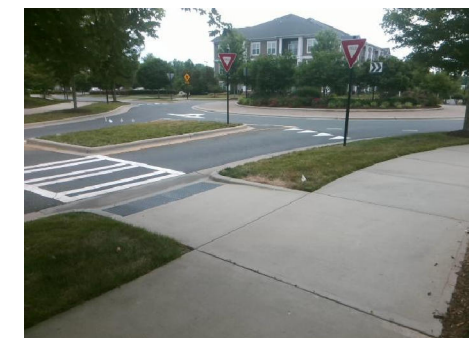
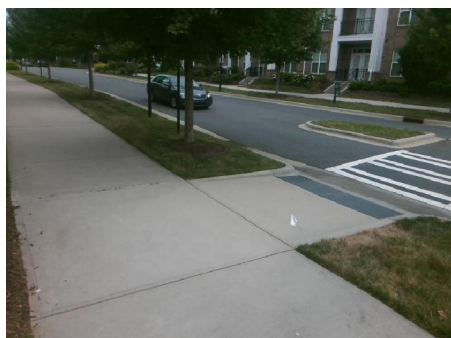
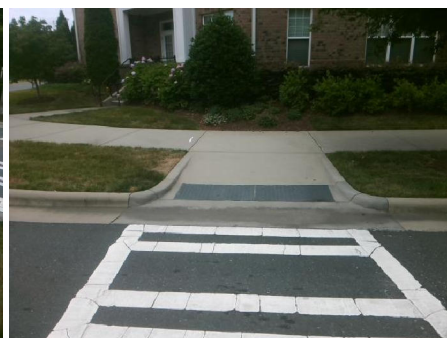
**Not Found, R304.5.3**

Compliance	Description	Data	Compliance	Description	Data
N/A	Ramp Length (in)	94.0	Yes	Ramp Slope (%)	6.7
Yes	Ramp Width (in)	95.0	No	Ramp XSlope (%)	2.6
N/A	Flare Type LT	N/A	N/A	Flare Type RT	N/A
N/A	Flare Slope LT (%)	N/A	N/A	Flare Slope RT (%)	N/A
N/A	Flare Traversable LT?	N/A	N/A	Flare Traversable RT?	N/A
N/A	Landing Length (in)	N/A	N/A	DWS Provided?	N/A
N/A	Landing Width (in)	N/A	N/A	DWS Contrast?	N/A
N/A	Landing Slope (%)	N/A	N/A	DWS Length (in)	N/A
N/A	Landing X Slope (%)	N/A	N/A	DWS Full Width?	N/A
N/A	Landing Curb? (Y/N)	N/A	N/A	DWS Offset (in)	N/A
N/A	Shared Landing?	N/A			
N/A	Gutter Ponding?	N/A	N/A	Gutter Slope (%)	N/A
N/A	Gutter Lip Ht (in)	N/A	N/A	Gutter X Slope (%)	N/A
N/A	Painted X Walk1?	Yes	N/A	Painted X Walk2?	N/A
	X Walk 1 Direction	To NW		X Walk 2 Direction	N/A
N/A	X Walk 1 Width (in)	89.0	N/A	X Walk 2 Width (in)	N/A
	X Walk 1 Slope (%)	2.5		X Walk 2 Slope (%)	N/A
	X Walk 1 X Slope (%)	0.3		X Walk 2 X Slope (%)	N/A

N/A	Ramp inside XWalk1?	Yes	N/A	Ramp inside XWalk2?	N/A
	Road Slope (%)	N/A	N/A	Clear Space?	N/A
	Road X Slope (%)	N/A	N/A	Clear Space to XWalk (in)	N/A
N/A	Any Obstructions?	N/A	N/A	Storm Grate/Utility Hazard?	N/A
	Obstruction Type			Storm Grate/Utility Type	
		N/A			N/A
		Yes		Surface Condition? (G/P)	Good

Possible Solutions:

**Remove & Replace Entire Ramp.**
