Access Compliance Report

Public Rights-of-Way

(Curb Ramps)

Intersection ID: 10025962	Main Street: ELM_LN	Cross Street: N/A	Location: NW
ADA ID: C24F77FE6950	Ramp Type: PerpDiag	Initial Pass/Fail: Fail	Overall Compliance: No
		Severity Score: 25

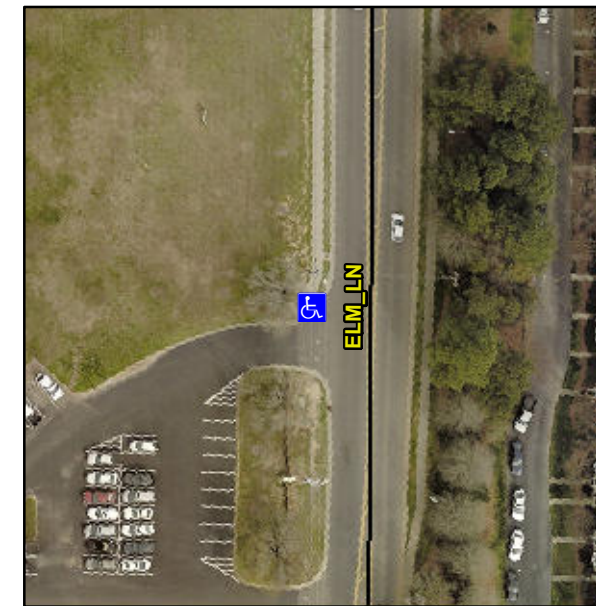
Not Found, R304.2.2, R304.5.3

Compliance	Description	Data	Compliance	Description	Data
N/A	Ramp Length (in)	108.0	No	Ramp Slope (%)	8.5
Yes	Ramp Width (in)	48.0	No	Ramp XSlope (%)	6.3
N/A	Flare Type LT	N/A	N/A	Flare Type RT	N/A
N/A	Flare Slope LT (%)	N/A	N/A	Flare Slope RT (%)	N/A
N/A	Flare Traversable LT?	N/A	N/A	Flare Traversable RT?	N/A
N/A	Landing Length (in)	N/A	N/A	DWS Provided?	N/A
N/A	Landing Width (in)	N/A	N/A	DWS Contrast?	N/A
N/A	Landing Slope (%)	N/A	N/A	DWS Length (in)	N/A
N/A	Landing X Slope (%)	N/A	N/A	DWS Full Width?	N/A
N/A	Landing Curb? (Y/N)	N/A	N/A	DWS Offset (in)	N/A
N/A	Shared Landing?	N/A			
N/A	Gutter Ponding?	N/A	N/A	Gutter Slope (%)	N/A
N/A	Gutter Lip Ht (in)	N/A	N/A	Gutter X Slope (%)	N/A
N/A	Painted X Walk1?	No	N/A	Painted X Walk2?	No
	X Walk 1 Direction	To SE		X Walk 2 Direction	To NE
N/A	X Walk 1 Width (in)	N/A	N/A	X Walk 2 Width (in)	N/A
	X Walk 1 Slope (%)	7.1		X Walk 2 Slope (%)	5.0
	X Walk 1 X Slope (%)	0.5		X Walk 2 X Slope (%)	6.3

N/A	Ramp inside XWalk1?	N/A	N/A	Ramp inside XWalk2?	N/A
	Road Slope (%)	4.7	N/A	Clear Space?	N/A
	Road X Slope (%)	6.4	N/A	Clear Space to XWalk (in)	N/A
N/A	Any Obstructions?	N/A	N/A	Storm Grate/Utility Hazard?	N/A
	Obstruction Type			Storm Grate/Utility Type	
		N/A			N/A
			Yes	Surface Condition? (G/P)	Good

Remove & Replace Curb Ramp With Two New Directional Ramps or Equivalent.
