# Access Compliance Report

## Public Rights-of-Way

### (Curb Ramps)

Intersection ID: 9989	Main Street: THE_PLAZA	Cross Street: TREMBETH_DR	Location: NW
ADA ID: C24F9A960BBA	Ramp Type: Perp	Initial Pass/Fail: Fail	Overall Compliance: No
		Severity Score: 8.75

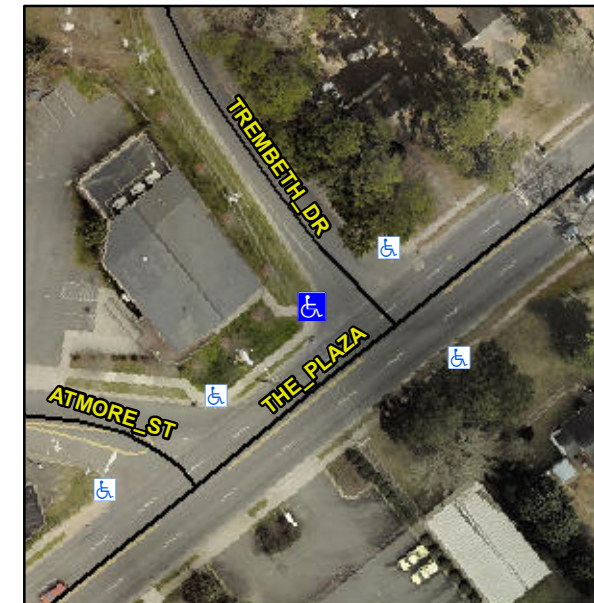
Compliance	Description	Data	Compliance	Description	Data
N/A	Ramp Length (in)	60.5	Yes	Ramp Slope (%)	7.8
No	Ramp Width (in)	47.0	Yes	Ramp XSlope (%)	0.7
N/A	Flare Type LT	N/A	N/A	Flare Type RT	N/A
N/A	Flare Slope LT (%)	N/A	N/A	Flare Slope RT (%)	N/A
N/A	Flare Traversable LT?	N/A	N/A	Flare Traversable RT?	N/A
N/A	Landing Length (in)	N/A	N/A	DWS Provided?	N/A
N/A	Landing Width (in)	N/A	N/A	DWS Contrast?	N/A
N/A	Landing Slope (%)	N/A	N/A	DWS Length (in)	N/A
N/A	Landing X Slope (%)	N/A	N/A	DWS Full Width?	N/A
N/A	Landing Curb? (Y/N)	N/A	N/A	DWS Offset (in)	N/A
N/A	Shared Landing?	N/A			
N/A	Gutter Ponding?	N/A	N/A	Gutter Slope (%)	N/A
N/A	Gutter Lip Ht (in)	N/A	N/A	Gutter X Slope (%)	N/A
N/A	Painted X Walk1?	No	N/A	Painted X Walk2?	N/A
	X Walk 1 Direction	To NE		X Walk 2 Direction	N/A
N/A	X Walk 1 Width (in)	N/A	N/A	X Walk 2 Width (in)	N/A
	X Walk 1 Slope (%)	0.2		X Walk 2 Slope (%)	N/A
	X Walk 1 X Slope (%)	2.3		X Walk 2 X Slope (%)	N/A

N/A	Ramp inside XWalk1?	N/A	N/A	Ramp inside XWalk2?	N/A
	Road Slope (%)	N/A	N/A	Clear Space?	N/A
	Road X Slope (%)	N/A	N/A	Clear Space to XWalk (in)	N/A
N/A	Any Obstructions?	N/A	N/A	Storm Grate/Utility Hazard?	N/A
	Obstruction Type			Storm Grate/Utility Type	
		N/A			N/A
			Yes	Surface Condition? (G/P)	Good

Possible Solutions:

**Remove & Replace Entire Ramp.**

**Not Found, R304.5.1**
