Access Compliance Report

Public Rights-of-Way

(Curb Ramps)

Intersection ID: 5520	Main Street: CARVER_BV	Cross Street: WASHINGTON_PL	Location:	N
ADA ID: C2536573F792	Ramp Type: Para	Initial Pass/Fail: Fail	Overall Compliance: No	Severity Score: 17.5
Codes/Mitigation Info/Possible Solution		Field Measurements/Component Compliance

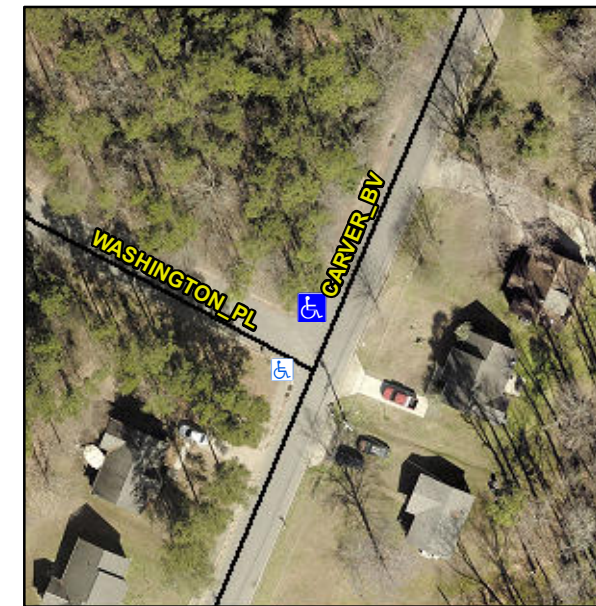
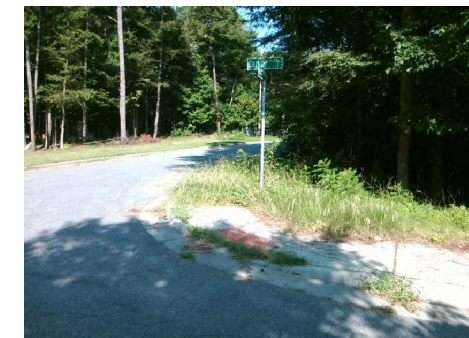
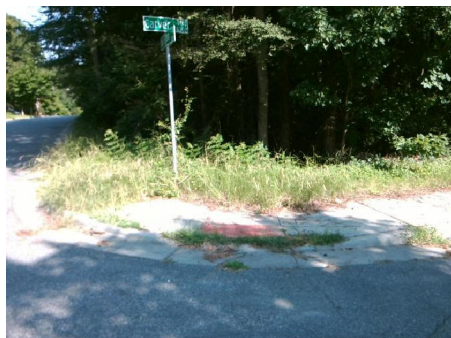
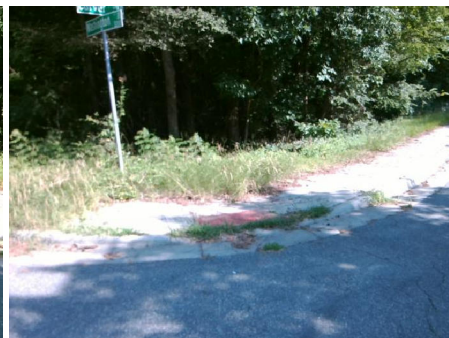
VEGETATION OVERGROWTH

Compliance	Description	Data	Compliance	Description	Data
N/A	Ramp Length LT (in)	55.0	N/A	Ramp Length RT (in)	54.0
No	Ramp Width LT (in)	35.0	No	Ramp Width RT (in)	36.0
Yes	Ramp Slope LT (%)	8.1	Yes	Ramp Slope RT (%)	7.5
Yes	Ramp XSlope LT (%)	1.1	Yes	Ramp XSlope RT (%)	0.9
N/A	Landing Length (in)	N/A	N/A	DWS Provided?	N/A
N/A	Landing Width (in)	N/A	N/A	DWS Contrast?	N/A
N/A	Landing Slope (%)	N/A	N/A	DWS Length (in)	N/A
N/A	Landing X Slope (%)	N/A	N/A	DWS Full Width?	N/A
N/A	Landing Curb? (Y/N)	N/A	N/A	DWS Offset (in)	N/A
N/A	Shared Landing?	N/A			
N/A	Gutter Ponding?	N/A	N/A	Gutter Slope (%)	N/A
N/A	Gutter Lip Ht (in)	N/A	N/A	Gutter X Slope (%)	N/A
N/A	Painted X Walk1?	No	N/A	Painted X Walk2?	N/A
	X Walk 1 Direction	To S		X Walk 2 Direction	N/A
N/A	X Walk 1 Width (in)	N/A	N/A	X Walk 2 Width (in)	N/A
	X Walk 1 Slope (%)	1.4		X Walk 2 Slope (%)	N/A
	X Walk 1 X Slope (%)	4.3		X Walk 2 X Slope (%)	N/A
N/A	Ramp inside XWalk1?	N/A	N/A	Ramp inside XWalk2?	N/A

Road Slope (%)	N/A	N/A	Clear Space?	N/A
	Road X Slope (%)	N/A	N/A	Clear Space to XWalk (in)	N/A
N/A	Any Obstructions?	N/A	N/A	Storm Grate/Utility Hazard?	N/A
	Obstruction Type			Storm Grate/Utility Type	
		N/A			N/A
			Yes	Surface Condition? (G/P)	Good
			N/A	Curb Slope (%)	9.3

Possible Solutions:

Remove & Replace Entire Ramp.
