Access Compliance Report

Public Rights-of-Way

(Curb Ramps)

Intersection ID: 14028	Main Street: JAMES_ST	Cross Street: WEST_BV	Location: SW
ADA ID: C2547BF86BD5	Ramp Type: PerpDiag	Initial Pass/Fail: Fail	Overall Compliance: No
			Severity Score: 33.75

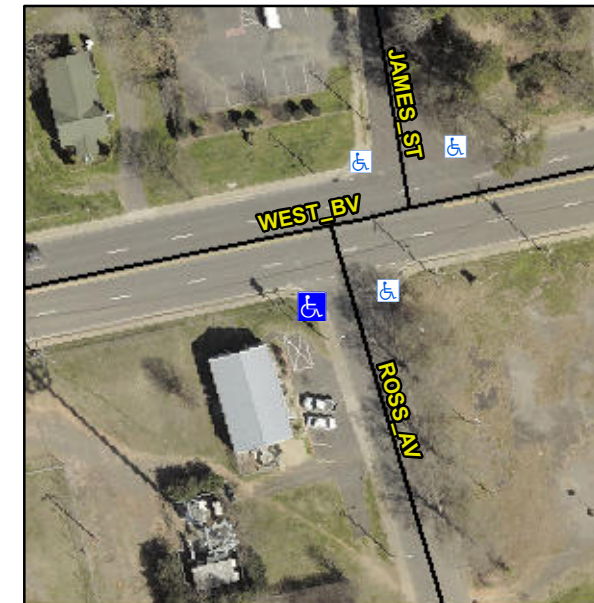
Not Found, R304.5.1, R304.2.2, R304.5.3

Compliance	Description	Data	Compliance	Description	Data
N/A	Ramp Length (in)	46.0	No	Ramp Slope (%)	9.4
No	Ramp Width (in)	41.0	No	Ramp XSlope (%)	6.2
N/A	Flare Type LT	N/A	N/A	Flare Type RT	N/A
N/A	Flare Slope LT (%)	N/A	N/A	Flare Slope RT (%)	N/A
N/A	Flare Traversable LT?	N/A	N/A	Flare Traversable RT?	N/A
N/A	Landing Length (in)	N/A	N/A	DWS Provided?	N/A
N/A	Landing Width (in)	N/A	N/A	DWS Contrast?	N/A
N/A	Landing Slope (%)	N/A	N/A	DWS Length (in)	N/A
N/A	Landing X Slope (%)	N/A	N/A	DWS Full Width?	N/A
N/A	Landing Curb? (Y/N)	N/A	N/A	DWS Offset (in)	N/A
N/A	Shared Landing?	N/A			
N/A	Gutter Ponding?	N/A	N/A	Gutter Slope (%)	N/A
N/A	Gutter Lip Ht (in)	N/A	N/A	Gutter X Slope (%)	N/A
N/A	Painted X Walk1?	No	N/A	Painted X Walk2?	No
	X Walk 1 Direction	To E		X Walk 2 Direction	To N
N/A	X Walk 1 Width (in)	N/A	N/A	X Walk 2 Width (in)	N/A
	X Walk 1 Slope (%)	0.1		X Walk 2 Slope (%)	3.4
	X Walk 1 X Slope (%)	2.8		X Walk 2 X Slope (%)	3.3

N/A	Ramp inside XWalk1?	N/A	N/A	Ramp inside XWalk2?	N/A
	Road Slope (%)	4.4	N/A	Clear Space?	N/A
	Road X Slope (%)	0.1	N/A	Clear Space to XWalk (in)	N/A
N/A	Any Obstructions?	N/A	N/A	Storm Grate/Utility Hazard?	N/A
	Obstruction Type			Storm Grate/Utility Type	
		N/A			N/A
			Yes	Surface Condition? (G/P)	Good

Remove & Replace Curb Ramp With Two New Directional Ramps or Equivalent.

Total Cost: \$ 3200.00
