Access Compliance Report

Public Rights-of-Way

(Curb Ramps)

Intersection ID: 15563	Main Street: GRANVILLE_RD	Cross Street: QUEENS_RD	Location: NE
ADA ID: C25841619C53	Ramp Type: Perp	Initial Pass/Fail: Fail	Overall Compliance: No
Severity Score: 12.5			
Codes/Mitigation Info/Possible Solution		Field Measurements/Component Compliance

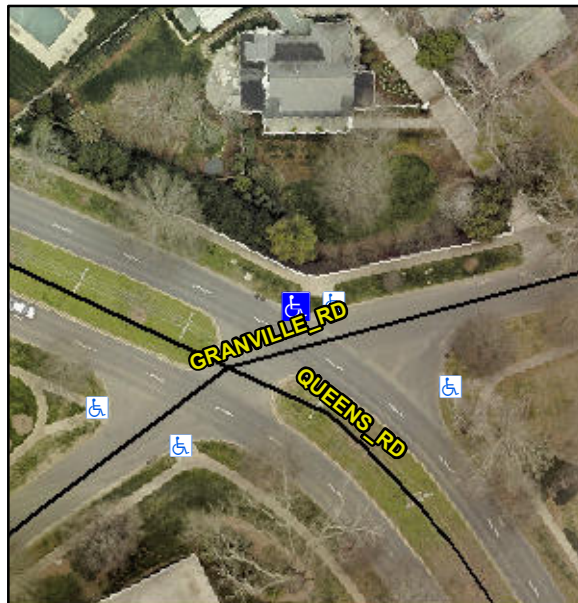
Compliance	Description	Data	Compliance	Description	Data
N/A	Ramp Length (in)	57.0	Yes	Ramp Slope (%)	6.9
Yes	Ramp Width (in)	48.0	No	Ramp XSlope (%)	5.4
N/A	Flare Type LT	N/A	N/A	Flare Type RT	N/A
N/A	Flare Slope LT (%)	N/A	N/A	Flare Slope RT (%)	N/A
N/A	Flare Traversable LT?	N/A	N/A	Flare Traversable RT?	N/A
N/A	Landing Length (in)	N/A	N/A	DWS Provided?	N/A
N/A	Landing Width (in)	N/A	N/A	DWS Contrast?	N/A
N/A	Landing Slope (%)	N/A	N/A	DWS Length (in)	N/A
N/A	Landing X Slope (%)	N/A	N/A	DWS Full Width?	N/A
N/A	Landing Curb? (Y/N)	N/A	N/A	DWS Offset (in)	N/A
N/A	Shared Landing?	N/A			
N/A	Gutter Ponding?	N/A	N/A	Gutter Slope (%)	N/A
N/A	Gutter Lip Ht (in)	N/A	N/A	Gutter X Slope (%)	N/A
N/A	Painted X Walk1?	No	N/A	Painted X Walk2?	N/A
	X Walk 1 Direction	To SW		X Walk 2 Direction	N/A
N/A	X Walk 1 Width (in)	N/A	N/A	X Walk 2 Width (in)	N/A
	X Walk 1 Slope (%)	4.2		X Walk 2 Slope (%)	N/A
	X Walk 1 X Slope (%)	0.6		X Walk 2 X Slope (%)	N/A

N/A	Ramp inside XWalk1?	N/A	N/A	Ramp inside XWalk2?	N/A
	Road Slope (%)	N/A	N/A	Clear Space?	N/A
	Road X Slope (%)	N/A	N/A	Clear Space to XWalk (in)	N/A
N/A	Any Obstructions?	N/A	N/A	Storm Grate/Utility Hazard?	N/A
	Obstruction Type			Storm Grate/Utility Type	
		N/A			N/A
		Yes		Surface Condition? (G/P)	Good

Possible Solutions:

Remove & Replace Entire Ramp.

Not Found, R304.5.3
