# Access Compliance Report

## Public Rights-of-Way

### (Curb Ramps)

Intersection ID: 8896	Main Street: LISA_CAROLE_DR	Cross Street: STONE_BLUFF_CT	Location:	E
ADA ID: C25AB2EC7953	Ramp Type: Perp	Initial Pass/Fail: Fail	Overall Compliance: No	Severity Score: 8.75
Codes/Mitigation Info/Possible Solution		Field Measurements/Component Compliance

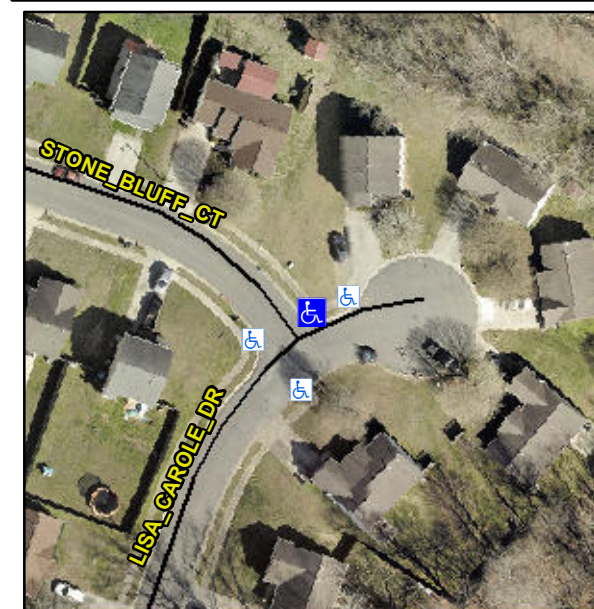
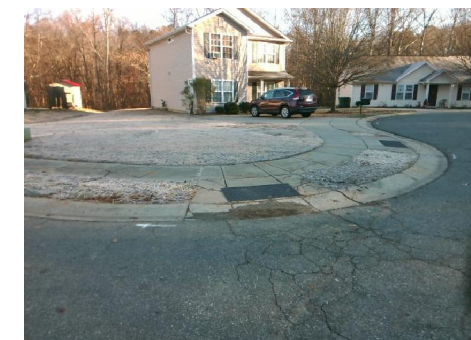
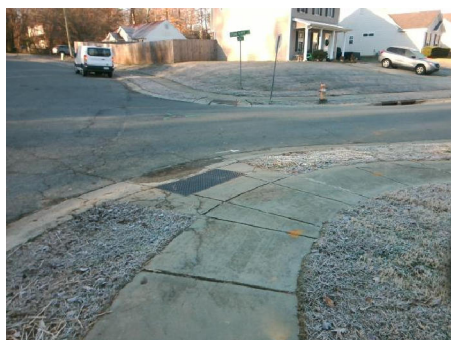
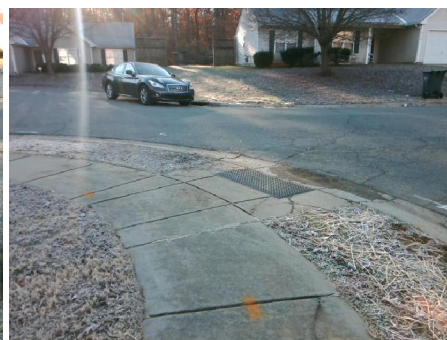
Compliance	Description	Data	Compliance	Description	Data
N/A	Ramp Length (in)	49.0	Yes	Ramp Slope (%)	6.6
No	Ramp Width (in)	36.0	Yes	Ramp XSlope (%)	1.1
N/A	Flare Type LT	N/A	N/A	Flare Type RT	N/A
N/A	Flare Slope LT (%)	N/A	N/A	Flare Slope RT (%)	N/A
N/A	Flare Traversable LT?	N/A	N/A	Flare Traversable RT?	N/A
N/A	Landing Length (in)	N/A	N/A	DWS Provided?	N/A
N/A	Landing Width (in)	N/A	N/A	DWS Contrast?	N/A
N/A	Landing Slope (%)	N/A	N/A	DWS Length (in)	N/A
N/A	Landing X Slope (%)	N/A	N/A	DWS Full Width?	N/A
N/A	Landing Curb? (Y/N)	N/A	N/A	DWS Offset (in)	N/A
N/A	Shared Landing?	N/A			
N/A	Gutter Ponding?	Yes	N/A	Gutter Slope (%)	N/A
N/A	Gutter Lip Ht (in)	N/A	N/A	Gutter X Slope (%)	N/A
N/A	Painted X Walk1?	No	N/A	Painted X Walk2?	N/A
	X Walk 1 Direction	To SW		X Walk 2 Direction	N/A
N/A	X Walk 1 Width (in)	N/A	N/A	X Walk 2 Width (in)	N/A
	X Walk 1 Slope (%)	4.1		X Walk 2 Slope (%)	N/A
	X Walk 1 X Slope (%)	2.3		X Walk 2 X Slope (%)	N/A

N/A	Ramp inside XWalk1?	N/A	N/A	Ramp inside XWalk2?	N/A
	Road Slope (%)	N/A	N/A	Clear Space?	N/A
	Road X Slope (%)	N/A	N/A	Clear Space to XWalk (in)	N/A
N/A	Any Obstructions?	N/A	N/A	Storm Grate/Utility Hazard?	N/A
	Obstruction Type			Storm Grate/Utility Type	
		N/A			N/A
			Yes	Surface Condition? (G/P)	Good

**Remove & Replace Entire Ramp.**

Total Cost: \$ 1850.00
