Access Compliance Report Public Rights-of-Way (Curb Ramps)

Main Street: DRAPER AV Cross Street: MERRY OAKS RD Location: SE Intersection ID: 13154 **ADA ID: C26FEE3DCABC** Ramp Type: PerpDiag Initial Pass/Fail: Fail **Overall Compliance: No** 10 **Severity Score:**

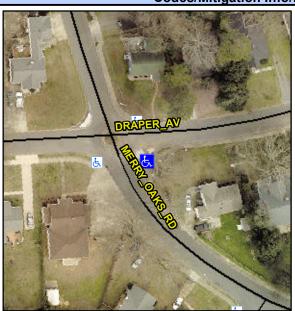
Not Found, R304.5.1, R304.5.3

Street 1 Name Stop Condition-Street 2 Street 2 Name Stop Condition-Street 1 **DRAPER AV** YieldSign Remove & Replace Curb Ramp With Two New Directional Ramps or Equivalent.
