# Access Compliance Report

## Public Rights-of-Way

### (Curb Ramps)

| Intersection ID: 10034403 | Main Street: PIEDMONT_ROW_DR_SOUTH | Cross Street: N/A | Location: NW |

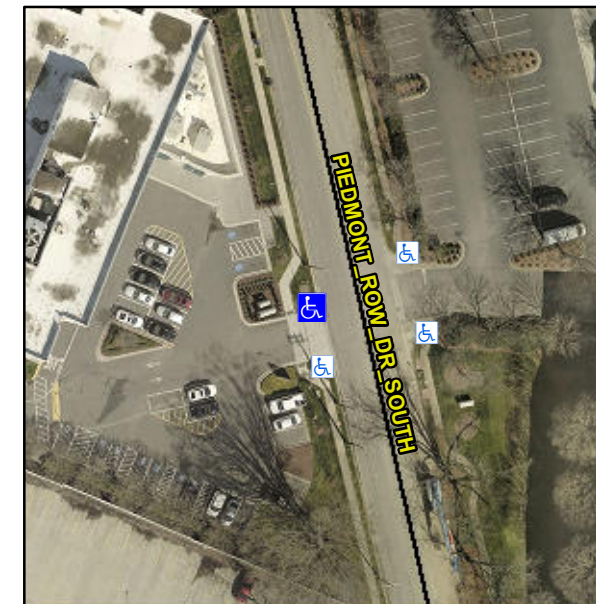
| ADA ID: C274CB8556FF | Ramp Type: BlendTrans2 | Initial Pass/Fail: Pass | Overall Compliance: No |
| | | Severity Score: 2.5 | |

**Not Found, R305.1.4, R305.2**

| Compliance | Description | Data | Compliance | Description | Data |
|---|---|---|---|---|---|
| N/A | Landing X Slope (%) | N/A | No | DWS Full Width? | No |
| N/A | Landing Curb? (Y/N) | No | No | DWS Offset (in) | 4.0 |
| | | | No | Curb Slope (%) | 5.1 |

Possible Solutions:

**Remove & Replace Curb Ramp With Two New Directional Ramps or Equivalent.**

Total Cost: \$ 3200.00
