Access Compliance Report

Public Rights-of-Way

(Curb Ramps)

Intersection ID: 45891	Main Street: PROSPERITY_CHURCH_RD	Cross Street: STONE_PARK_DR	Location: NW
ADA ID: C28EF8F9A69A	Ramp Type: PerpDiag	Initial Pass/Fail: Fail	Overall Compliance: No
		Severity Score: 10

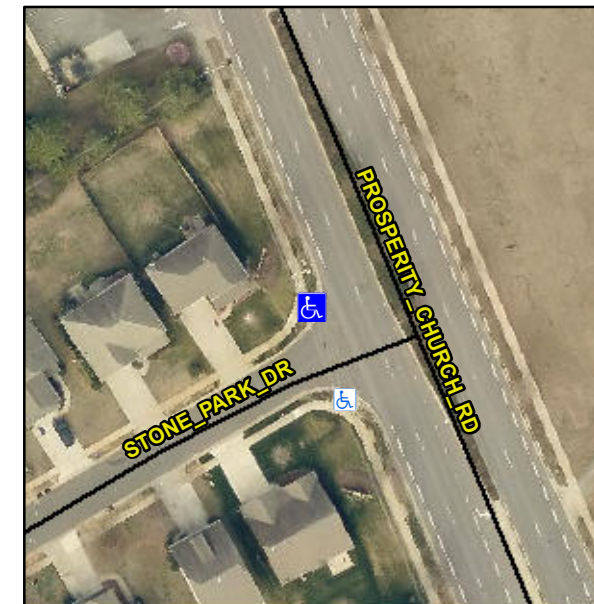
Not Found, R304.5.1, R304.5.3

Compliance	Description	Data	Compliance	Description	Data
N/A	Ramp Length (in)	73.0	Yes	Ramp Slope (%)	7.0
No	Ramp Width (in)	36.0	No	Ramp XSlope (%)	3.0
N/A	Flare Type LT	N/A	N/A	Flare Type RT	N/A
N/A	Flare Slope LT (%)	N/A	N/A	Flare Slope RT (%)	N/A
N/A	Flare Traversable LT?	N/A	N/A	Flare Traversable RT?	N/A
N/A	Landing Length (in)	N/A	N/A	DWS Provided?	N/A
N/A	Landing Width (in)	N/A	N/A	DWS Contrast?	N/A
N/A	Landing Slope (%)	N/A	N/A	DWS Length (in)	N/A
N/A	Landing X Slope (%)	N/A	N/A	DWS Full Width?	N/A
N/A	Landing Curb? (Y/N)	N/A	N/A	DWS Offset (in)	N/A
N/A	Shared Landing?	N/A			
N/A	Gutter Ponding?	N/A	N/A	Gutter Slope (%)	N/A
N/A	Gutter Lip Ht (in)	N/A	N/A	Gutter X Slope (%)	N/A
N/A	Painted X Walk1?	No	N/A	Painted X Walk2?	No
	X Walk 1 Direction	To E		X Walk 2 Direction	To S
N/A	X Walk 1 Width (in)	N/A	N/A	X Walk 2 Width (in)	N/A
	X Walk 1 Slope (%)	2.2		X Walk 2 Slope (%)	3.4
	X Walk 1 X Slope (%)	2.5		X Walk 2 X Slope (%)	0.9

N/A	Ramp inside XWalk1?	N/A	N/A	Ramp inside XWalk2?	N/A
	Road Slope (%)	3.4	N/A	Clear Space?	N/A
	Road X Slope (%)	4.3	N/A	Clear Space to XWalk (in)	N/A
N/A	Any Obstructions?	N/A	N/A	Storm Grate/Utility Hazard?	N/A
	Obstruction Type			Storm Grate/Utility Type	
		N/A			N/A
		Yes		Surface Condition? (G/P)	Good

Remove & Replace Curb Ramp With Two New Directional Ramps or Equivalent.
