Access Compliance Report

Public Rights-of-Way

(Curb Ramps)

Intersection ID: 13046	Main Street: CENTRAL_AV	Cross Street: LAMAR_AV	Location: SE
ADA ID: C2928F86D23D	Ramp Type: Perp	Initial Pass/Fail: Fail	Overall Compliance: No
			Severity Score: 13.75

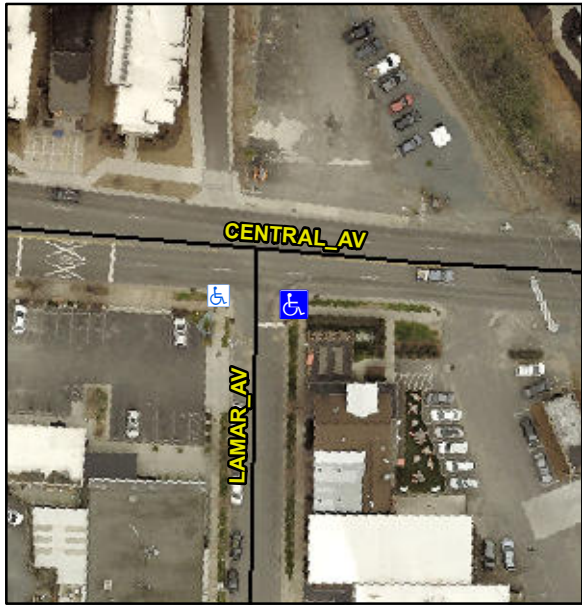
Possible Solutions:			Compliance	Description	Data	Compliance	Description	Data
	Remove & Replace Entire Ramp.	N/A	Ramp Length (in)	70.5	No	Ramp Slope (%)	9.5		
		Yes	Ramp Width (in)	49.0	No	Ramp XSlope (%)	3.8		
		N/A	Flare Type LT	N/A	N/A	Flare Type RT	N/A		
		N/A	Flare Slope LT (%)	N/A	N/A	Flare Slope RT (%)	N/A		
		N/A	Flare Traversable LT?	N/A	N/A	Flare Traversable RT?	N/A		
		N/A	Landing Length (in)	N/A	N/A	DWS Provided?	N/A		
		N/A	Landing Width (in)	N/A	N/A	DWS Contrast?	N/A		
		N/A	Landing Slope (%)	N/A	N/A	DWS Length (in)	N/A		
		N/A	Landing X Slope (%)	N/A	N/A	DWS Full Width?	N/A		
Surveyor Notes:	N/A	N/A	Landing Curb? (Y/N)	N/A	N/A	DWS Offset (in)	N/A		
		N/A	Shared Landing?	N/A					
		N/A	Gutter Ponding?	N/A	N/A	Gutter Slope (%)	N/A		
		N/A	Gutter Lip Ht (in)	N/A	N/A	Gutter X Slope (%)	N/A		
		N/A	Painted X Walk1?	No	N/A	Painted X Walk2?	N/A

X Walk 1 Direction	To W		X Walk 2 Direction	N/A		
		N/A	X Walk 1 Width (in)	N/A	N/A	X Walk 2 Width (in)	N/A		
			X Walk 1 Slope (%)	0.9		X Walk 2 Slope (%)	N/A		
			X Walk 1 X Slope (%)	0.3		X Walk 2 X Slope (%)	N/A		
		N/A	Ramp inside XWalk1?	N/A	N/A	Ramp inside XWalk2?	N/A		
PROW/ADA:			Road Slope (%)	N/A	N/A	Clear Space?	N/A		
			Road X Slope (%)	N/A	N/A	Clear Space to XWalk (in)	N/A		
		N/A	Any Obstructions?	N/A	N/A	Storm Grate/Utility Hazard?	N/A		
			Obstruction Type			Storm Grate/Utility Type			
					N/A		N/A		
					Yes	Surface Condition? (G/P)	Good
