Access Compliance Report

Public Rights-of-Way

(Curb Ramps)

Intersection ID: 13848	Main Street: CENTRAL_AV	Cross Street: MEDALLION_DR	Location: NW
ADA ID: C29F5563A807	Ramp Type: Perp	Initial Pass/Fail: Fail	Overall Compliance: No
Severity Score: 17.5			
Codes/Mitigation Info/Possible Solution		Field Measurements/Component Compliance

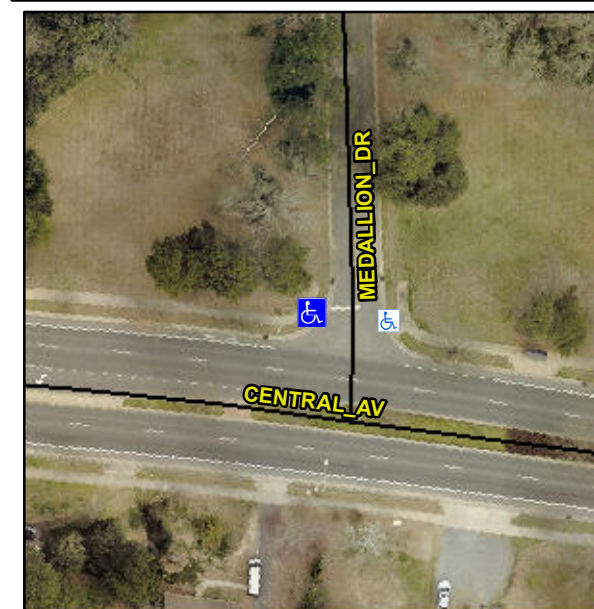
Not Found, R304.5.1

Compliance	Description	Data	Compliance	Description	Data
N/A	Ramp Length (in)	60.0	Yes	Ramp Slope (%)	5.6
No	Ramp Width (in)	33.0	Yes	Ramp XSlope (%)	0.3
N/A	Flare Type LT	N/A	N/A	Flare Type RT	N/A
N/A	Flare Slope LT (%)	N/A	N/A	Flare Slope RT (%)	N/A
N/A	Flare Traversable LT?	N/A	N/A	Flare Traversable RT?	N/A
N/A	Landing Length (in)	N/A	N/A	DWS Provided?	N/A
N/A	Landing Width (in)	N/A	N/A	DWS Contrast?	N/A
N/A	Landing Slope (%)	N/A	N/A	DWS Length (in)	N/A
N/A	Landing X Slope (%)	N/A	N/A	DWS Full Width?	N/A
N/A	Landing Curb? (Y/N)	N/A	N/A	DWS Offset (in)	N/A
N/A	Shared Landing?	N/A			
N/A	Gutter Ponding?	N/A	N/A	Gutter Slope (%)	N/A
N/A	Gutter Lip Ht (in)	N/A	N/A	Gutter X Slope (%)	N/A
N/A	Painted X Walk1?	No	N/A	Painted X Walk2?	N/A
	X Walk 1 Direction	To SE		X Walk 2 Direction	N/A
N/A	X Walk 1 Width (in)	N/A	N/A	X Walk 2 Width (in)	N/A
	X Walk 1 Slope (%)	0.6		X Walk 2 Slope (%)	N/A
	X Walk 1 X Slope (%)	0.7		X Walk 2 X Slope (%)	N/A

N/A	Ramp inside XWalk1?	N/A	N/A	Ramp inside XWalk2?	N/A
	Road Slope (%)	N/A	N/A	Clear Space?	N/A
	Road X Slope (%)	N/A	N/A	Clear Space to XWalk (in)	N/A
N/A	Any Obstructions?	N/A	N/A	Storm Grate/Utility Hazard?	N/A
	Obstruction Type			Storm Grate/Utility Type	
		N/A			N/A
		Yes		Surface Condition? (G/P)	Good

Remove & Replace Entire Ramp.
