# Access Compliance Report

## Public Rights-of-Way

### (Curb Ramps)

| Intersection ID: 43357 | Main Street: PROSPERITY_VIEW_DR | Cross Street: WOODLAND_COMMONS_DR | Location: E |

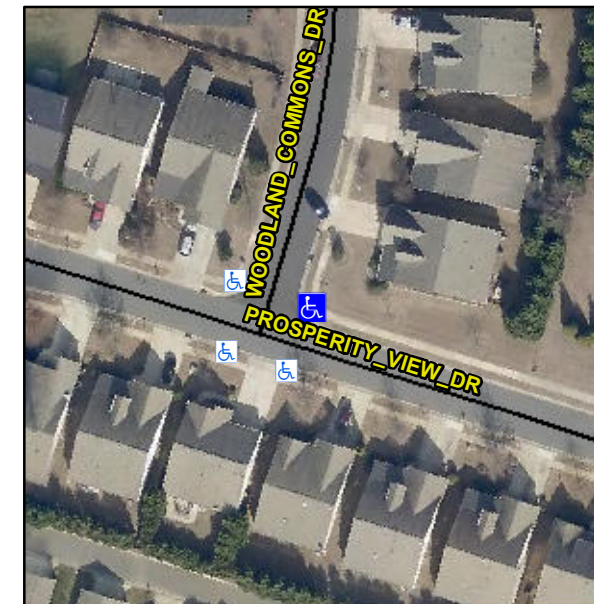
**Not Found, R304.5.1, R304.2.2**

| Compliance | Description | Data | Compliance | Description | Data |
|---|---|---|---|---|---|
| N/A | Ramp Length (in) | 47.0 | No | Ramp Slope (%) | 9.6 |
| No | Ramp Width (in) | 38.5 | Yes | Ramp XSlope (%) | 0.9 |

**Remove & Replace Curb Ramp With Two New Directional Ramps or Equivalent.**
