Access Compliance Report

Public Rights-of-Way

(Curb Ramps)

| Intersection ID: 48856 | Main Street: GREENFINCH_DR | Cross Street: NEELY_GLEN_DR | Location: NE |

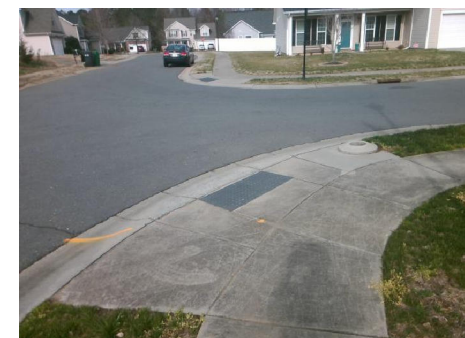
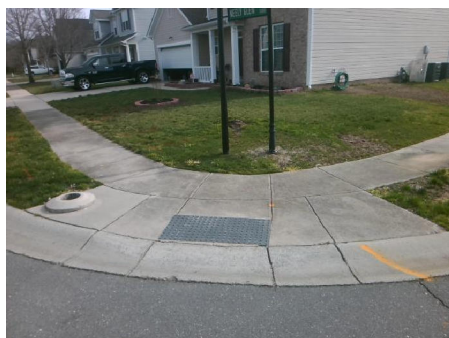
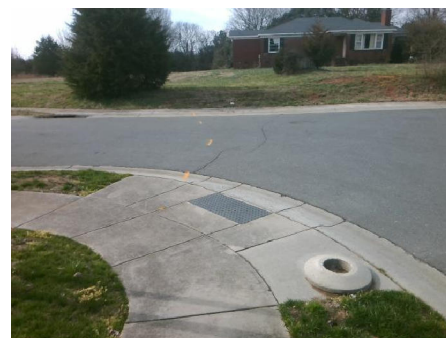
| ADA ID: C2A79222BD6F | Ramp Type: BlendTrans2 | Initial Pass/Fail: Fail | Overall Compliance: No |
| Severity Score: 10 | | | |

R304.5.1, R304.5.3

| Compliance | Description | Data | Compliance | Description | Data |
|---|---|---|---|---|---|
| No | Ramp Width (in) | 41.0 | No | BlendTrans XSlope (%) | 3.5 |

Remove & Replace Curb Ramp With Two New Directional Ramps or Equivalent.

Total Cost: \$ 3200.00
