Access Compliance Report

Public Rights-of-Way

(Curb Ramps)

Intersection ID: 17250	Main Street: CROYDON_RD	Cross Street: QUEENS_RD_WEST	Location: NE
ADA ID: C2A8F005D2FE	Ramp Type: Perp	Initial Pass/Fail: Pass	Overall Compliance: No
Codes/Mitigation Info/Possible Solution		Field Measurements/Component Compliance	
Severity Score: 17.75

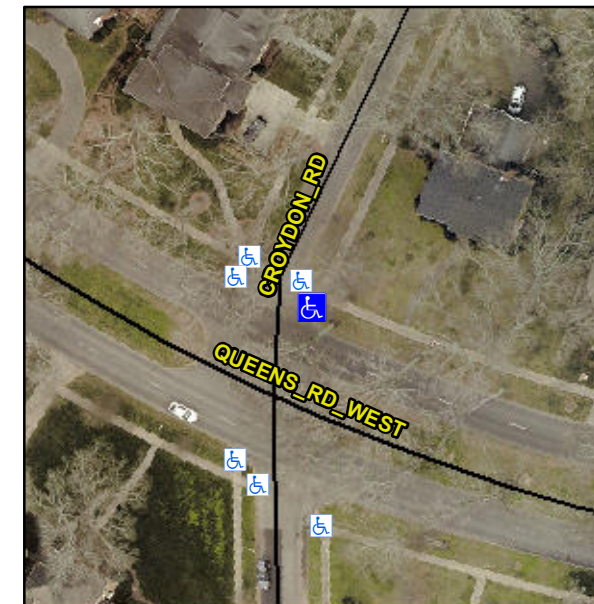
Not Found, R304.5.3, R305, R302.7.2

Compliance	Description	Data	Compliance	Description	Data
N/A	Ramp Length (in)	114.0	Yes	Ramp Slope (%)	7.0
Yes	Ramp Width (in)	58.0	No	Ramp XSlope (%)	4.0
N/A	Flare Type LT	None	N/A	Flare Type RT	N/A
N/A	Flare Slope LT (%)	N/A	N/A	Flare Slope RT (%)	N/A
N/A	Flare Traversable LT?	N/A	N/A	Flare Traversable RT?	N/A
Yes	Landing Length (in)	62.0	No	DWS Provided?	No
Yes	Landing Width (in)	59.0	N/A	DWS Contrast?	No
Yes	Landing Slope (%)	1.6	N/A	DWS Length (in)	N/A
No	Landing X Slope (%)	3.0	N/A	DWS Full Width?	No
N/A	Landing Curb? (Y/N)	No	N/A	DWS Offset (in)	N/A
N/A	Shared Landing?	No			
Yes	Gutter Ponding?	No	Yes	Gutter Slope (%)	0.9
No	Gutter Lip Ht (in)	0.5	Yes	Gutter X Slope (%)	1.0
N/A	Painted X Walk1?	No	N/A	Painted X Walk2?	N/A
	X Walk 1 Direction	To S		X Walk 2 Direction	N/A
N/A	X Walk 1 Width (in)	N/A	N/A	X Walk 2 Width (in)	N/A
	X Walk 1 Slope (%)	1.0		X Walk 2 Slope (%)	N/A
	X Walk 1 X Slope (%)	1.3		X Walk 2 X Slope (%)	N/A

N/A	Ramp inside XWalk1?	N/A	N/A	Ramp inside XWalk2?	N/A
	Road Slope (%)	N/A	N/A	Clear Space?	Yes
	Road X Slope (%)	N/A	N/A	Clear Space to XWalk (in)	N/A
Yes	Any Obstructions?	No	Yes	Storm Grate/Utility Hazard?	No
	Obstruction Type			Storm Grate/Utility Type	
		N/A			N/A
			Yes	Surface Condition? (G/P)	Good

Remove & Replace Entire Ramp.
