# Access Compliance Report

## Public Rights-of-Way

### (Curb Ramps)

Intersection ID: 45169	Main Street: HAZELVIEW_DR	Cross Street: LINDEN_TREE_LN	Location: SW
ADA ID: C2B4F4249AD5	Ramp Type: PerpDiag	Initial Pass/Fail: Fail	Overall Compliance: No
		Severity Score: 8.75

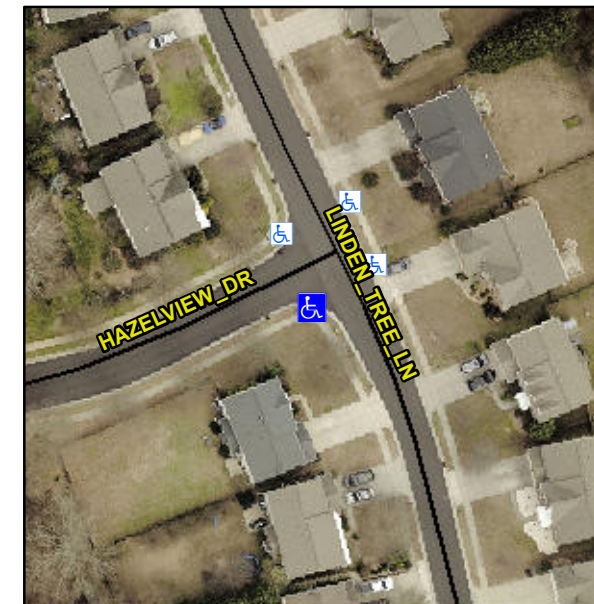
Compliance	Description	Data	Compliance	Description	Data
N/A	Ramp Length (in)	41.0	Yes	Ramp Slope (%)	6.2
No	Ramp Width (in)	44.0	Yes	Ramp XSlope (%)	1.6
N/A	Flare Type LT	N/A	N/A	Flare Type RT	N/A
N/A	Flare Slope LT (%)	N/A	N/A	Flare Slope RT (%)	N/A
N/A	Flare Traversable LT?	N/A	N/A	Flare Traversable RT?	N/A
N/A	Landing Length (in)	N/A	N/A	DWS Provided?	N/A
N/A	Landing Width (in)	N/A	N/A	DWS Contrast?	N/A
N/A	Landing Slope (%)	N/A	N/A	DWS Length (in)	N/A
N/A	Landing X Slope (%)	N/A	N/A	DWS Full Width?	N/A
N/A	Landing Curb? (Y/N)	N/A	N/A	DWS Offset (in)	N/A
N/A	Shared Landing?	N/A			
N/A	Gutter Ponding?	N/A	N/A	Gutter Slope (%)	N/A
N/A	Gutter Lip Ht (in)	N/A	N/A	Gutter X Slope (%)	N/A
N/A	Painted X Walk1?	No	N/A	Painted X Walk2?	No
	X Walk 1 Direction	To E		X Walk 2 Direction	To NW
N/A	X Walk 1 Width (in)	N/A	N/A	X Walk 2 Width (in)	N/A
	X Walk 1 Slope (%)	3.5		X Walk 2 Slope (%)	2.5
	X Walk 1 X Slope (%)	0.2		X Walk 2 X Slope (%)	2.4

N/A	Ramp inside XWalk1?	N/A	N/A	Ramp inside XWalk2?	N/A
	Road Slope (%)	1.3	N/A	Clear Space?	N/A
	Road X Slope (%)	2.4	N/A	Clear Space to XWalk (in)	N/A
N/A	Any Obstructions?	N/A	N/A	Storm Grate/Utility Hazard?	N/A
	Obstruction Type			Storm Grate/Utility Type	
		N/A			N/A
			Yes	Surface Condition? (G/P)	Good

**Remove & Replace Curb Ramp With Two New Directional Ramps or Equivalent.**
