# Access Compliance Report

## Public Rights-of-Way

### (Curb Ramps)

| Intersection ID: 2754 | Main Street: KINGLET_LN | Cross Street: WINGMONT_DR | Location: SW |

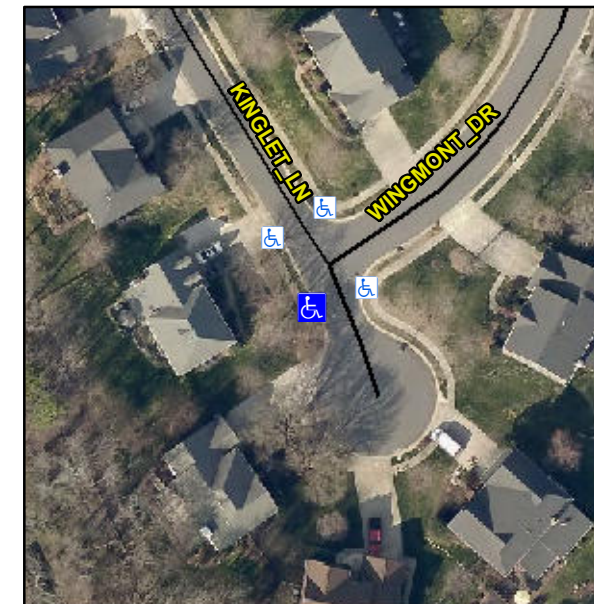
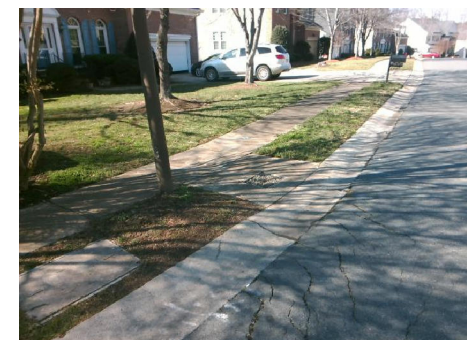
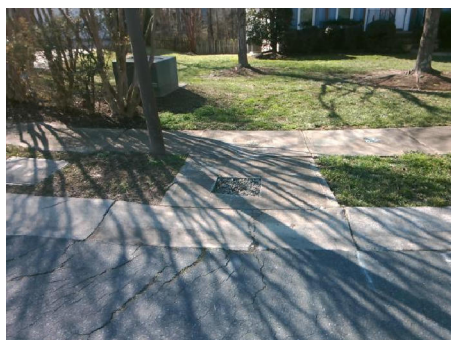
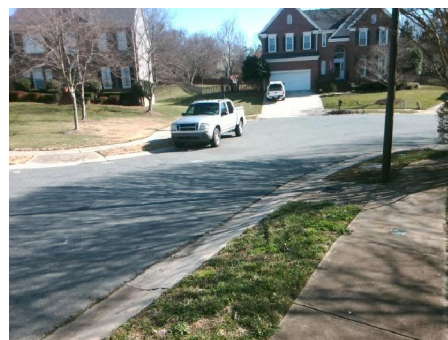
| ADA ID: C2B5AE800ACE | Ramp Type: BlendTrans1 | Initial Pass/Fail: Pass | Overall Compliance: No |

**HOLE IN RAMP**

**R304.2.1, R304.2.2-Perp, R304.3.2-Para, R304.5.3, R305, R302.7.2**

| Compliance | Description | Data | Compliance | Description | Data |
|---|---|---|---|---|---|
| No | Landing Length (in) | 44.0 | No | DWS Provided? | No |
| No | Landing Slope (%) | 2.3 | N/A | DWS Length (in) | N/A |
| No | Landing X Slope (%) | 5.5 | N/A | DWS Full Width? | No |
| No | Gutter Lip Ht (in) | 1.3 | Yes | Gutter X Slope (%) | 0.9 |

**Remove & Replace Curb Ramp With Two New Directional Ramps or Equivalent. Grind Gutter Lip.**
