## Access Compliance Report Public Rights-of-Way (Curb Ramps)

Intersection ID: 20158Main Street: GAULEY\_CRCross Street: GRIERS\_FORK\_DRLocation:NEADA ID: C2B96CC0E29DRamp Type: PerpDiagInitial Pass/Fail: FailOverall Compliance: NoSeverity Score:10

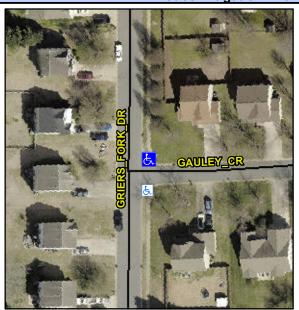
Compliance Description		Data	Comp	liance Desc	ription	Data
N/A	Ramp Length (in)	47.0	Yes Ramp Slope (%)		7.3	
No	Ramp Width (in)	36.0	No	Ramp XSlope (%)		3.0
N/A	Flare Type LT	N/A	N/A	Flare Type RT		N/A
N/A	Flare Slope LT (%)	N/A	N/A	Flare Slope	RT (%)	N/A
N/A	Flare Traversable LT?	N/A	N/A	Flare Trave	rsable RT?	N/A
N/A	Landing Length (in)	N/A	N/A	DWS Provi	ded?	N/A
N/A	Landing Width (in)	N/A	N/A	DWS Contr	ast?	N/A
N/A	Landing Slope (%)	N/A	N/A	DWS Lengt	th (in)	N/A
N/A	Landing X Slope (%)	N/A	N/A	DWS Full V	Vidth?	N/A
N/A	Landing Curb? (Y/N)	N/A	N/A	DWS Offse	t (in)	N/A
N/A	Shared Landing?	N/A				
N/A	Gutter Ponding?	N/A	N/A	Gutter Slop	e (%)	N/A
N/A	Gutter Lip Ht (in)	N/A	N/A	Gutter X SI	ope (%)	N/A
N/A	Painted X Walk1?	No	N/A	Painted X V	Valk2?	No
	X Walk 1 Direction	To NW		X Walk 2 D	irection	To SW
N/A	X Walk 1 Width (in)	N/A	N/A	X Walk 2 W	idth (in)	N/A
	X Walk 1 Slope (%)	1.4		X Walk 2 S	lope (%)	1.7

X Walk 1 X Slope (%)	0.0		X Walk 2 X	Slope (%)	2.3
N/A	Ramp inside XWalk1?	N/A	N/A	Ramp insid	e XWalk2?	N/A
	Road Slope (%)	0.5	N/A	Clear Spac	e?	N/A
	Road X Slope (%)	1.8	N/A	Clear Spac	e to XWalk (in)	N/A
N/A	Any Obstructions?	N/A	N/A	Storm Grat	e/Utility Hazard?	N/A
	Obstruction Type			Storm Grat	e/Utility Type	
		N/A				N/A
			Yes	Surface Co	ndition? (G/P)	Good

Remove & Replace Curb Ramp With Two New Directional Ramps or Equivalent.

R304.5.1, R304.5.3
