# Access Compliance Report

## Public Rights-of-Way

### (Curb Ramps)

Intersection ID: 10039127	Main Street: SUMMERHILL_RIDGE_DR	Cross Street: N/A	Location: SE
ADA ID: C2BCA4C18033	Ramp Type: Perp	Initial Pass/Fail: Fail	Overall Compliance: No
Severity Score: 42.5			
Codes/Mitigation Info/Possible Solution		Field Measurements/Component Compliance

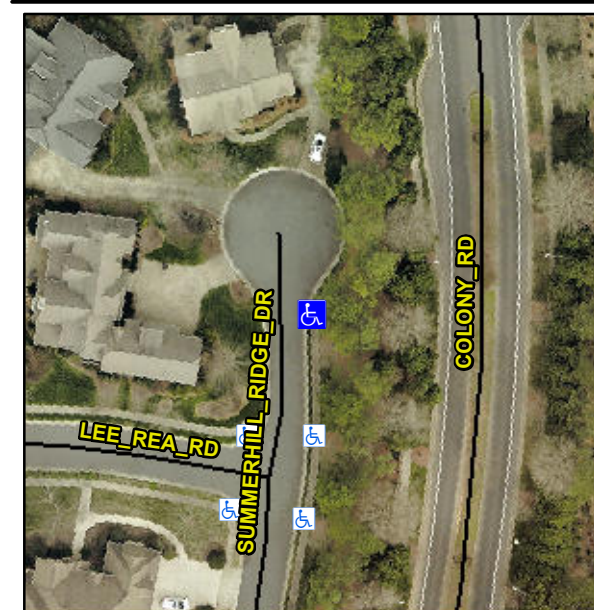
Compliance	Description	Data	Compliance	Description	Data
N/A	Ramp Length (in)	24.0	No	Ramp Slope (%)	13.1
No	Ramp Width (in)	32.0	Yes	Ramp XSlope (%)	0.5
N/A	Flare Type LT	N/A	N/A	Flare Type RT	N/A
N/A	Flare Slope LT (%)	N/A	N/A	Flare Slope RT (%)	N/A
N/A	Flare Traversable LT?	N/A	N/A	Flare Traversable RT?	N/A
N/A	Landing Length (in)	N/A	N/A	DWS Provided?	N/A
N/A	Landing Width (in)	N/A	N/A	DWS Contrast?	N/A
N/A	Landing Slope (%)	N/A	N/A	DWS Length (in)	N/A
N/A	Landing X Slope (%)	N/A	N/A	DWS Full Width?	N/A
N/A	Landing Curb? (Y/N)	N/A	N/A	DWS Offset (in)	N/A
N/A	Shared Landing?	N/A			
N/A	Gutter Ponding?	N/A	N/A	Gutter Slope (%)	N/A
N/A	Gutter Lip Ht (in)	N/A	N/A	Gutter X Slope (%)	N/A
N/A	Painted X Walk1?	No	N/A	Painted X Walk2?	N/A
	X Walk 1 Direction	To NW		X Walk 2 Direction	N/A
N/A	X Walk 1 Width (in)	N/A	N/A	X Walk 2 Width (in)	N/A
	X Walk 1 Slope (%)	2.4		X Walk 2 Slope (%)	N/A
	X Walk 1 X Slope (%)	1.3		X Walk 2 X Slope (%)	N/A

N/A	Ramp inside XWalk1?	N/A	N/A	Ramp inside XWalk2?	N/A
	Road Slope (%)	N/A	N/A	Clear Space?	N/A
	Road X Slope (%)	N/A	N/A	Clear Space to XWalk (in)	N/A
N/A	Any Obstructions?	N/A	N/A	Storm Grate/Utility Hazard?	N/A
	Obstruction Type			Storm Grate/Utility Type	
		N/A			N/A
			Yes	Surface Condition? (G/P)	Good

Possible Solutions:

**Remove & Replace Entire Ramp.**

**R304.5.1, R304.2.2**

Total Cost: \$ 1850.00
