Access Compliance Report

Public Rights-of-Way

(Curb Ramps)

Intersection ID: N/A	Main Street: SOUTH_BV	Cross Street: HEBRON_ST	Location: SE
ADA ID: C2C49A86A757	Ramp Type: Perp	Initial Pass/Fail: Fail	Overall Compliance: No
Severity Score: 25			
Codes/Mitigation Info/Possible Solution		Field Measurements/Component Compliance

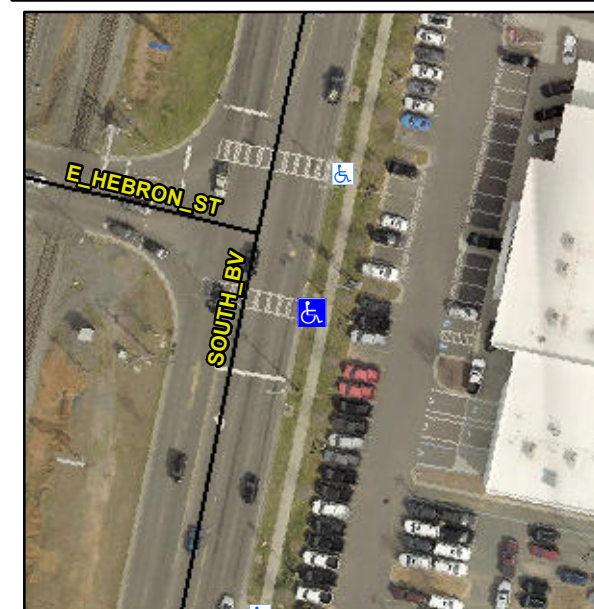
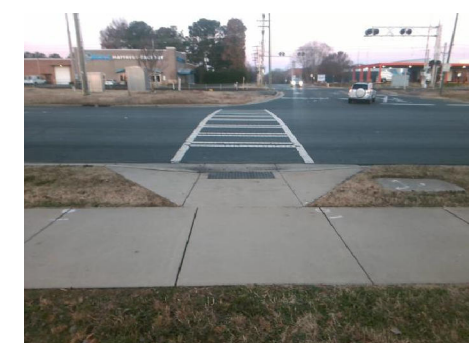
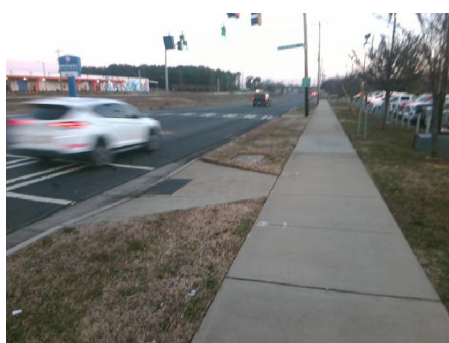
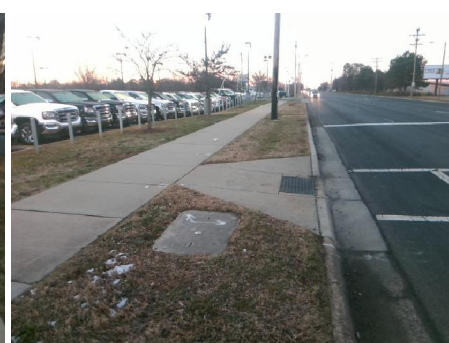
R304.2.2, R304.5.3

Compliance	Description	Data	Compliance	Description	Data
N/A	Ramp Length (in)	96.0	No	Ramp Slope (%)	8.7
Yes	Ramp Width (in)	61.0	No	Ramp XSlope (%)	5.4
N/A	Flare Type LT	N/A	N/A	Flare Type RT	N/A
N/A	Flare Slope LT (%)	N/A	N/A	Flare Slope RT (%)	N/A
N/A	Flare Traversable LT?	N/A	N/A	Flare Traversable RT?	N/A
N/A	Landing Length (in)	N/A	N/A	DWS Provided?	N/A
N/A	Landing Width (in)	N/A	N/A	DWS Contrast?	N/A
N/A	Landing Slope (%)	N/A	N/A	DWS Length (in)	N/A
N/A	Landing X Slope (%)	N/A	N/A	DWS Full Width?	N/A
N/A	Landing Curb? (Y/N)	N/A	N/A	DWS Offset (in)	N/A
N/A	Shared Landing?	N/A			
N/A	Gutter Ponding?	N/A	N/A	Gutter Slope (%)	N/A
N/A	Gutter Lip Ht (in)	N/A	N/A	Gutter X Slope (%)	N/A
N/A	Painted X Walk1?	Yes	N/A	Painted X Walk2?	N/A
	X Walk 1 Direction	To W		X Walk 2 Direction	N/A
N/A	X Walk 1 Width (in)	109.0	N/A	X Walk 2 Width (in)	N/A
	X Walk 1 Slope (%)	3.9		X Walk 2 Slope (%)	N/A
	X Walk 1 X Slope (%)	1.4		X Walk 2 X Slope (%)	N/A

N/A	Ramp inside XWalk1?	Yes	N/A	Ramp inside XWalk2?	N/A
	Road Slope (%)	N/A	N/A	Clear Space?	N/A
	Road X Slope (%)	N/A	N/A	Clear Space to XWalk (in)	N/A
N/A	Any Obstructions?	N/A	N/A	Storm Grate/Utility Hazard?	N/A
	Obstruction Type			Storm Grate/Utility Type	
		N/A			N/A
		Yes		Surface Condition? (G/P)	Good

Remove & Replace Entire Ramp.

Total Cost: \$ 1850.00
