Access Compliance Report

Public Rights-of-Way

(Curb Ramps)

Intersection ID: 19699	Main Street: CHERRYCREST_LN	Cross Street: ROCKY_RIDGE_DR	Location: SW
ADA ID: C2C698A40D2D	Ramp Type: PerpDiag	Initial Pass/Fail: Fail	Overall Compliance: No
Severity Score: 12.5			
Codes/Mitigation Info/Possible Solution		Field Measurements/Component Compliance

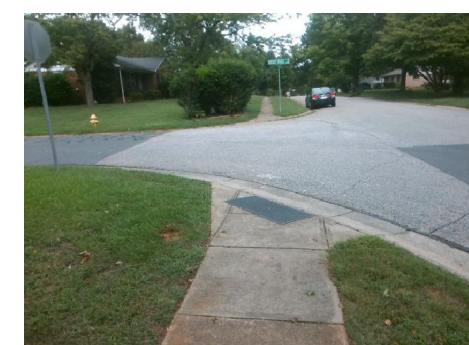
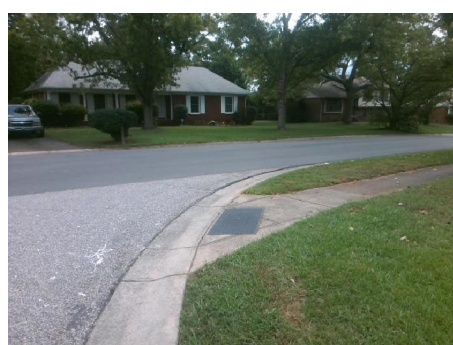
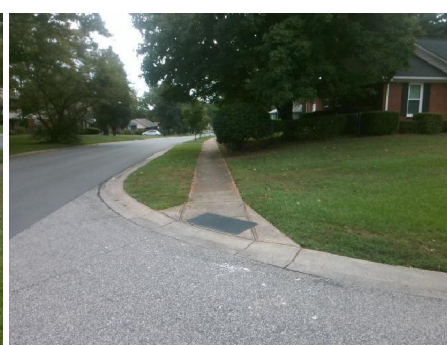
Not Found, R304.2.2

Compliance	Description	Data	Compliance	Description	Data
N/A	Ramp Length (in)	43.0	No	Ramp Slope (%)	9.0
Yes	Ramp Width (in)	48.0	Yes	Ramp XSlope (%)	1.9
N/A	Flare Type LT	N/A	N/A	Flare Type RT	N/A
N/A	Flare Slope LT (%)	N/A	N/A	Flare Slope RT (%)	N/A
N/A	Flare Traversable LT?	N/A	N/A	Flare Traversable RT?	N/A
N/A	Landing Length (in)	N/A	N/A	DWS Provided?	N/A
N/A	Landing Width (in)	N/A	N/A	DWS Contrast?	N/A
N/A	Landing Slope (%)	N/A	N/A	DWS Length (in)	N/A
N/A	Landing X Slope (%)	N/A	N/A	DWS Full Width?	N/A
N/A	Landing Curb? (Y/N)	N/A	N/A	DWS Offset (in)	N/A
N/A	Shared Landing?	N/A			
N/A	Gutter Ponding?	N/A	N/A	Gutter Slope (%)	N/A
N/A	Gutter Lip Ht (in)	N/A	N/A	Gutter X Slope (%)	N/A
N/A	Painted X Walk1?	No	N/A	Painted X Walk2?	No
	X Walk 1 Direction	To E		X Walk 2 Direction	To N
N/A	X Walk 1 Width (in)	N/A	N/A	X Walk 2 Width (in)	N/A
	X Walk 1 Slope (%)	0.9		X Walk 2 Slope (%)	3.5
	X Walk 1 X Slope (%)	3.2		X Walk 2 X Slope (%)	3.8

N/A	Ramp inside XWalk1?	N/A	N/A	Ramp inside XWalk2?	N/A
	Road Slope (%)	1.2	N/A	Clear Space?	N/A
	Road X Slope (%)	8.7	N/A	Clear Space to XWalk (in)	N/A
N/A	Any Obstructions?	N/A	N/A	Storm Grate/Utility Hazard?	N/A
	Obstruction Type			Storm Grate/Utility Type	
		N/A			N/A
			Yes	Surface Condition? (G/P)	Good

Remove & Replace Curb Ramp With Two New Directional Ramps or Equivalent.

Total Cost: \$ 3200.00
