Access Compliance Report

Public Rights-of-Way

(Curb Ramps)

Intersection ID: 14642	Main Street: DRESDEN_DR_WEST	Cross Street: NORLAND_RD	Location:	N
ADA ID: C2CD0DF88EE7	Ramp Type: PerpDiag	Initial Pass/Fail: Fail	Overall Compliance: No	Severity Score: 1.25
Codes/Mitigation Info/Possible Solution		Field Measurements/Component Compliance

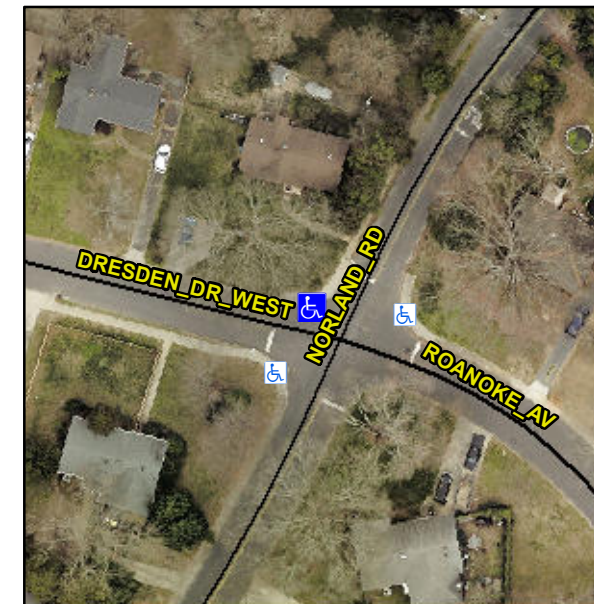
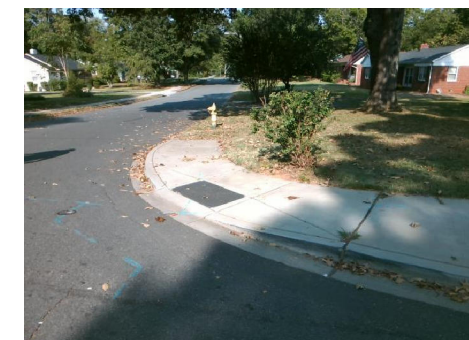
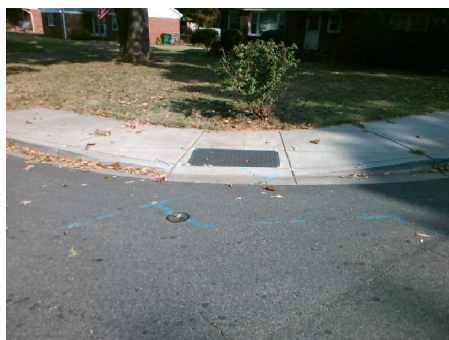
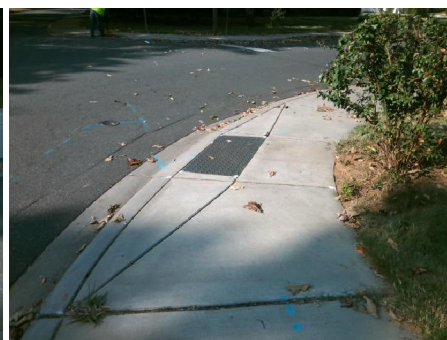
Not Found, R304.5.3

Compliance	Description	Data	Compliance	Description	Data
N/A	Ramp Length (in)	61.0	Yes	Ramp Slope (%)	7.0
Yes	Ramp Width (in)	49.0	No	Ramp XSlope (%)	4.2
N/A	Flare Type LT	N/A	N/A	Flare Type RT	N/A
N/A	Flare Slope LT (%)	N/A	N/A	Flare Slope RT (%)	N/A
N/A	Flare Traversable LT?	N/A	N/A	Flare Traversable RT?	N/A
N/A	Landing Length (in)	N/A	N/A	DWS Provided?	N/A
N/A	Landing Width (in)	N/A	N/A	DWS Contrast?	N/A
N/A	Landing Slope (%)	N/A	N/A	DWS Length (in)	N/A
N/A	Landing X Slope (%)	N/A	N/A	DWS Full Width?	N/A
N/A	Landing Curb? (Y/N)	N/A	N/A	DWS Offset (in)	N/A
N/A	Shared Landing?	N/A			
N/A	Gutter Ponding?	N/A	N/A	Gutter Slope (%)	N/A
N/A	Gutter Lip Ht (in)	N/A	N/A	Gutter X Slope (%)	N/A
N/A	Painted X Walk1?	No	N/A	Painted X Walk2?	No
	X Walk 1 Direction	To SW		X Walk 2 Direction	To SE
N/A	X Walk 1 Width (in)	N/A	N/A	X Walk 2 Width (in)	N/A
	X Walk 1 Slope (%)	5.3		X Walk 2 Slope (%)	8.6
	X Walk 1 X Slope (%)	9.5		X Walk 2 X Slope (%)	0.3

N/A	Ramp inside XWalk1?	N/A	N/A	Ramp inside XWalk2?	N/A
	Road Slope (%)	5.4	N/A	Clear Space?	N/A
	Road X Slope (%)	7.0	N/A	Clear Space to XWalk (in)	N/A
N/A	Any Obstructions?	N/A	N/A	Storm Grate/Utility Hazard?	N/A
	Obstruction Type			Storm Grate/Utility Type	
		N/A			N/A
			Yes	Surface Condition? (G/P)	Good

Remove & Replace Curb Ramp With Two New Directional Ramps or Equivalent.
