Access Compliance Report

Public Rights-of-Way

(Curb Ramps)

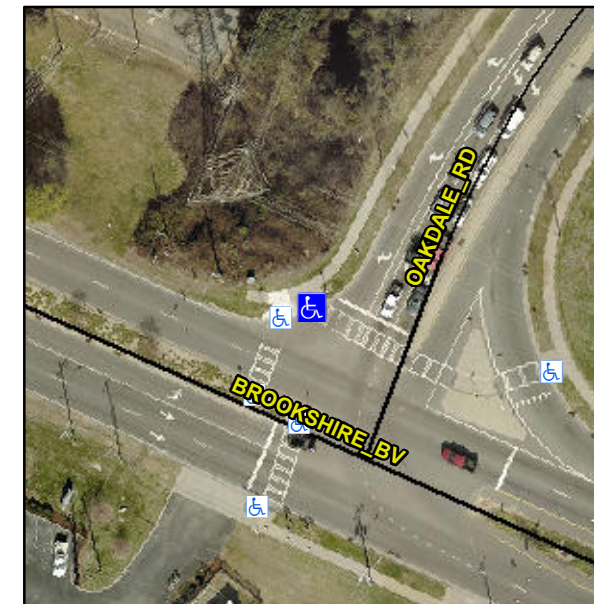
Intersection ID: 7031	Main Street: BROOKSHIRE_BV	Cross Street: OAKDALE_RD	Location:	N
ADA ID: C2D23AD9D1EA	Ramp Type: Perp	Initial Pass/Fail: Fail	Overall Compliance: No	Severity Score: 8.75
Codes/Mitigation Info/Possible Solution		Field Measurements/Component Compliance

Not Found, R304.5.1

Compliance	Description	Data	Compliance	Description	Data
N/A	Ramp Length (in)	95.0	Yes	Ramp Slope (%)	7.9
No	Ramp Width (in)	41.0	Yes	Ramp XSlope (%)	0.9
N/A	Flare Type LT	N/A	N/A	Flare Type RT	N/A
N/A	Flare Slope LT (%)	N/A	N/A	Flare Slope RT (%)	N/A
N/A	Flare Traversable LT?	N/A	N/A	Flare Traversable RT?	N/A
N/A	Landing Length (in)	N/A	N/A	DWS Provided?	N/A
N/A	Landing Width (in)	N/A	N/A	DWS Contrast?	N/A
N/A	Landing Slope (%)	N/A	N/A	DWS Length (in)	N/A
N/A	Landing X Slope (%)	N/A	N/A	DWS Full Width?	N/A
N/A	Landing Curb? (Y/N)	N/A	N/A	DWS Offset (in)	N/A
N/A	Shared Landing?	N/A			
N/A	Gutter Ponding?	N/A	N/A	Gutter Slope (%)	N/A
N/A	Gutter Lip Ht (in)	N/A	N/A	Gutter X Slope (%)	N/A
N/A	Painted X Walk1?	Yes	N/A	Painted X Walk2?	N/A
	X Walk 1 Direction	To SE		X Walk 2 Direction	N/A
N/A	X Walk 1 Width (in)	113.0	N/A	X Walk 2 Width (in)	N/A
	X Walk 1 Slope (%)	1.3		X Walk 2 Slope (%)	N/A
	X Walk 1 X Slope (%)	0.9		X Walk 2 X Slope (%)	N/A

N/A	Ramp inside XWalk1?	Yes	N/A	Ramp inside XWalk2?	N/A
	Road Slope (%)	N/A	N/A	Clear Space?	N/A
	Road X Slope (%)	N/A	N/A	Clear Space to XWalk (in)	N/A
N/A	Any Obstructions?	N/A	N/A	Storm Grate/Utility Hazard?	N/A
	Obstruction Type			Storm Grate/Utility Type	
		N/A			N/A
			Yes	Surface Condition? (G/P)	Good

Remove & Replace Entire Ramp.

Total Cost: \$ 1850.00
