Access Compliance Report

Public Rights-of-Way

(Curb Ramps)

Intersection ID: 50583	Main Street: GRAND_FIR_RD	Cross Street: LONGSTRAW_RD	Location: NW
ADA ID: C2D590087EC6	Ramp Type: Perp	Initial Pass/Fail: Fail	Overall Compliance: No
Severity Score: 8.75			
Codes/Mitigation Info/Possible Solution		Field Measurements/Component Compliance

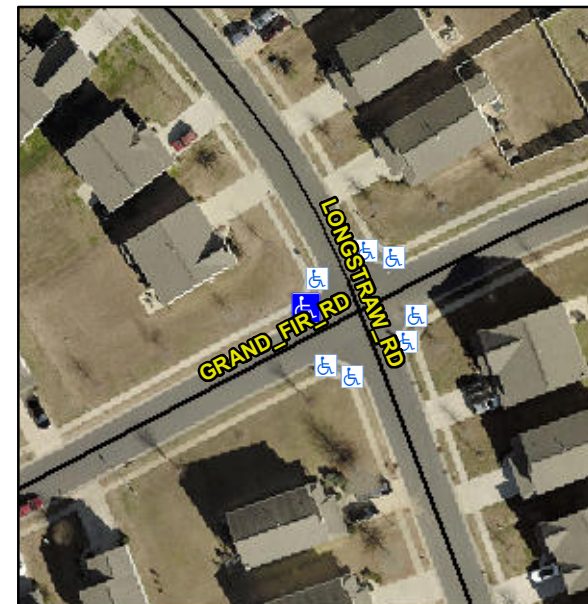
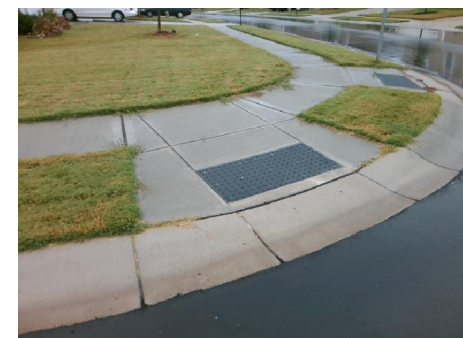
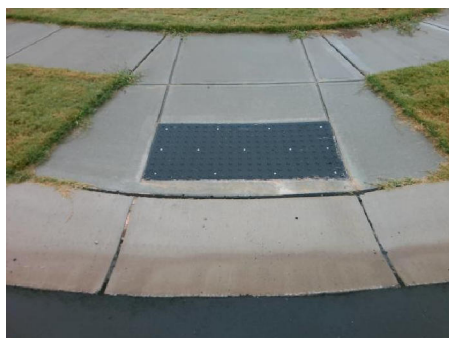
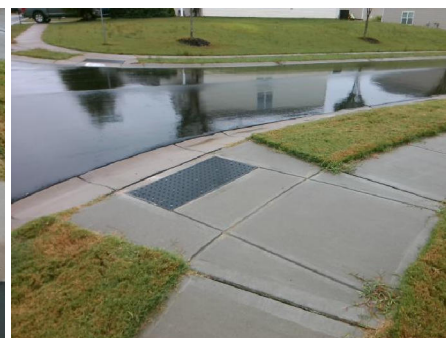
Not Found, R304.5.1

Compliance	Description	Data	Compliance	Description	Data
N/A	Ramp Length (in)	51.0	Yes	Ramp Slope (%)	6.9
No	Ramp Width (in)	47.5	Yes	Ramp XSlope (%)	0.4
N/A	Flare Type LT	N/A	N/A	Flare Type RT	N/A
N/A	Flare Slope LT (%)	N/A	N/A	Flare Slope RT (%)	N/A
N/A	Flare Traversable LT?	N/A	N/A	Flare Traversable RT?	N/A
N/A	Landing Length (in)	N/A	N/A	DWS Provided?	N/A
N/A	Landing Width (in)	N/A	N/A	DWS Contrast?	N/A
N/A	Landing Slope (%)	N/A	N/A	DWS Length (in)	N/A
N/A	Landing X Slope (%)	N/A	N/A	DWS Full Width?	N/A
N/A	Landing Curb? (Y/N)	N/A	N/A	DWS Offset (in)	N/A
N/A	Shared Landing?	N/A			
N/A	Gutter Ponding?	N/A	N/A	Gutter Slope (%)	N/A
N/A	Gutter Lip Ht (in)	N/A	N/A	Gutter X Slope (%)	N/A
N/A	Painted X Walk1?	No	N/A	Painted X Walk2?	N/A
	X Walk 1 Direction	To S		X Walk 2 Direction	N/A
N/A	X Walk 1 Width (in)	N/A	N/A	X Walk 2 Width (in)	N/A
	X Walk 1 Slope (%)	4.3		X Walk 2 Slope (%)	N/A
	X Walk 1 X Slope (%)	0.0		X Walk 2 X Slope (%)	N/A

N/A	Ramp inside XWalk1?	N/A	N/A	Ramp inside XWalk2?	N/A
	Road Slope (%)	N/A	N/A	Clear Space?	N/A
	Road X Slope (%)	N/A	N/A	Clear Space to XWalk (in)	N/A
N/A	Any Obstructions?	N/A	N/A	Storm Grate/Utility Hazard?	N/A
	Obstruction Type			Storm Grate/Utility Type	
		N/A			N/A
			Yes	Surface Condition? (G/P)	Good

Possible Solutions:

Remove & Replace Entire Ramp.

Total Cost: \$ 1850.00
