Access Compliance Report

Public Rights-of-Way

(Curb Ramps)

| Intersection ID: 52288 | Main Street: STEELE_CREEK_RD | Cross Street: DIXIE_RIVER_RD | Location: | N |

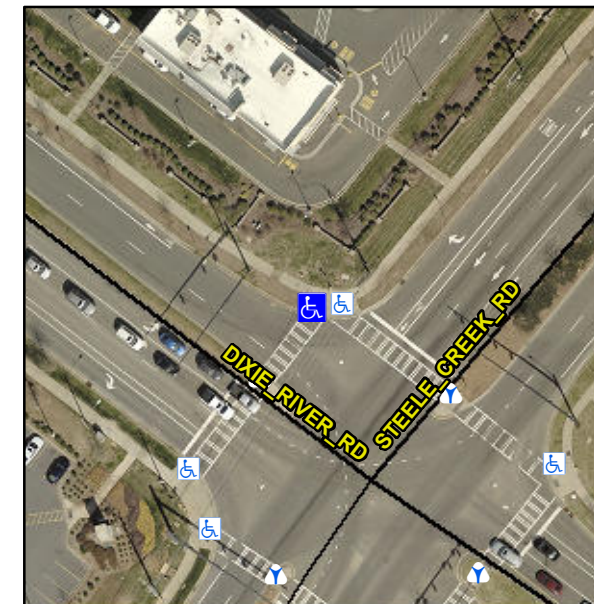
| ADA ID: C2DBF222BCA5 | Ramp Type: Para | Initial Pass/Fail: Fail | Overall Compliance: No | Severity Score: 12.5 |

Surveyor Notes:

RT RP < 5%

PROW/ADA:

R304.3.2

| Compliance | Description | Data | Compliance | Description | Data |
|---|---|---|---|---|---|
| No | Ramp Slope LT (%) | 9.0 | Yes | Ramp Slope RT (%) | 4.0 |

Possible Solutions:

Remove & Replace Entire Ramp.

Total Cost: \$ 1600.00
